## What caused this tank fire?

An unusual tank fire incident was reported earlier this year by the Petroleum Tank Management Association of Alberta (PMMAA), Canada.

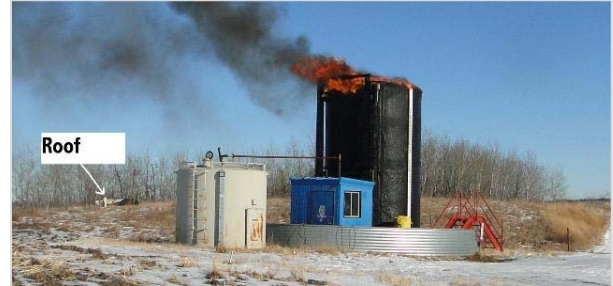
The county inspection agency reached no firm conclusion in its investigation report. All three elements of the fire triangle were present:

1. Oxygen, because the tank was not a closed system;
2. Fuel source, because a gas vent line was directed to the top of the tank; and
3. Ignition source.
