Former Fifth Church of Christ, Scientist

11623 Lake Avenue
Cleveland, Ohio 44102

Facility Assessment

October 1, 2009

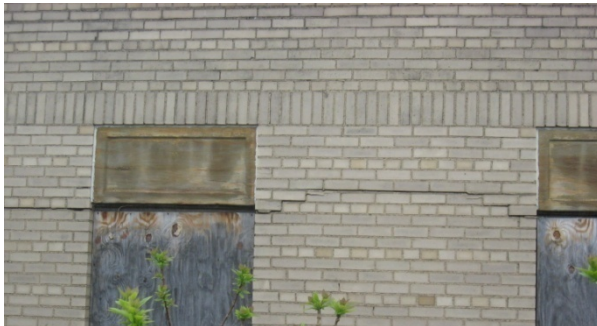
Exterior walls: The exterior sandstone appears saturated with moisture in many areas, exhibiting efflorescence (white salt-streaked and stained areas) and spalling of the face of the stone due to repeated freeze-thaw cycles. The one story wing along the southern portion of the building is clad in brick with sandstone lintels over window openings. There is a significant horizontal crack that extends along a large portion of this wall at the level of the window heads, likely caused by the expansion of the corroding steel lintel jacking up the masonry parapet above.

Masonry cracking aligned with existing window lintels at south wall

- **Critical masonry wall repairs:** Prioritize exterior wall repairs necessary for stability and weather resistance. Replace damaged lintels along south wall and rebuild parapet to level of existing roof. Tuckpoint severely damaged areas and install sealant at visible cracks and gaps.

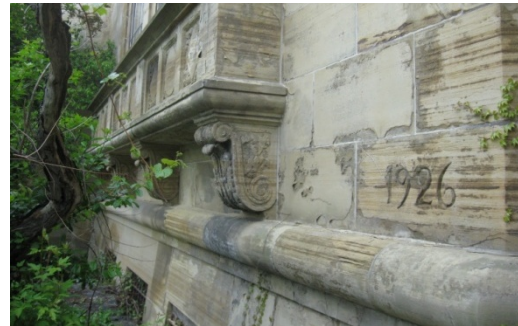
Sandstone spalling, efflorescence, and staining

- **Exterior Masonry Repair and Rehabilitation:** Extensive masonry restoration will be required, including cleaning all stone, removing the coating from the drum below the dome, replacing severely damaged stone pieces, patching stone with moderate damage. All joints should be tuckpointed throughout, and sealant installed in all skyward facing joints.

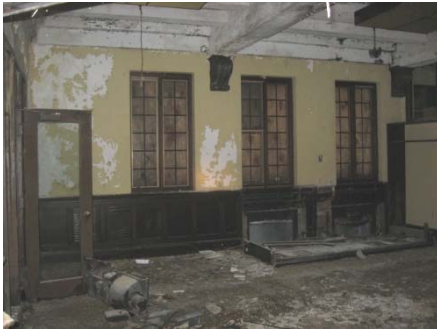
Reading Room

Building Interior: Continued moisture infiltration into the building has damaged or destroyed most interior finishes. Ornamental and flat plaster has become water saturated and much of it has collapsed to the floor. Portions remain that give a sense of the original profiles and details, but it must be assumed that any future re-use would need to re-create this detail anew – no significant areas remain substantially intact. Existing wood paneling, doors and similar moisture susceptible materials have also deteriorated completely. Marble wall panels, flooring, and tile flooring that are resistant to deterioration remain intact in many areas. The basement floor slab has heaved up in the western area of the basement, and while it does not appear to be an immediate concern, it would need to be removed and replaced for future use of the building.

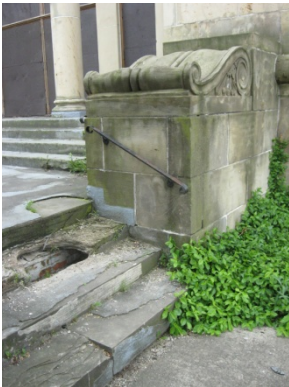
Site: Steps at the front entrance are deteriorated at some locations and require repairs. Areawells at the perimeter of the building have some trash and debris, but drains appear to be functioning enough to prevent flooding.

Deteriorated front steps

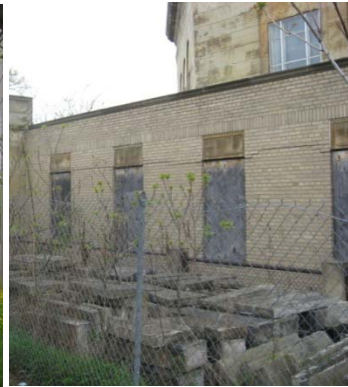
Existing fencing at south property boundary

- Security fencing: We recommend replacing existing fencing at the southwest side of the building with more extensive fencing along the eastern and southern boundaries of the property in order to restrict access to less visible sides of the building. We believe fencing along the streets on the north and west sides of the property does not offer a substantial security benefit if the building is stable and secure. Fencing should be heavy duty chainlink with a tight 1" mesh to be more resistant to cutting and climbing.
- Landscape: Continue pruning of trees and shrubs and general maintenance of landscaping to prevent an overgrown appearance and reduce hiding areas for vandals.
- Continue monitoring of the property on a periodic basis to promptly identify and remedy problems such as security breaches and moisture leakage.
