Fifth Church of Christ - Facility Assessment

11623 Lake Avenue

City Architecture Job No. 09033

October 1, 2009

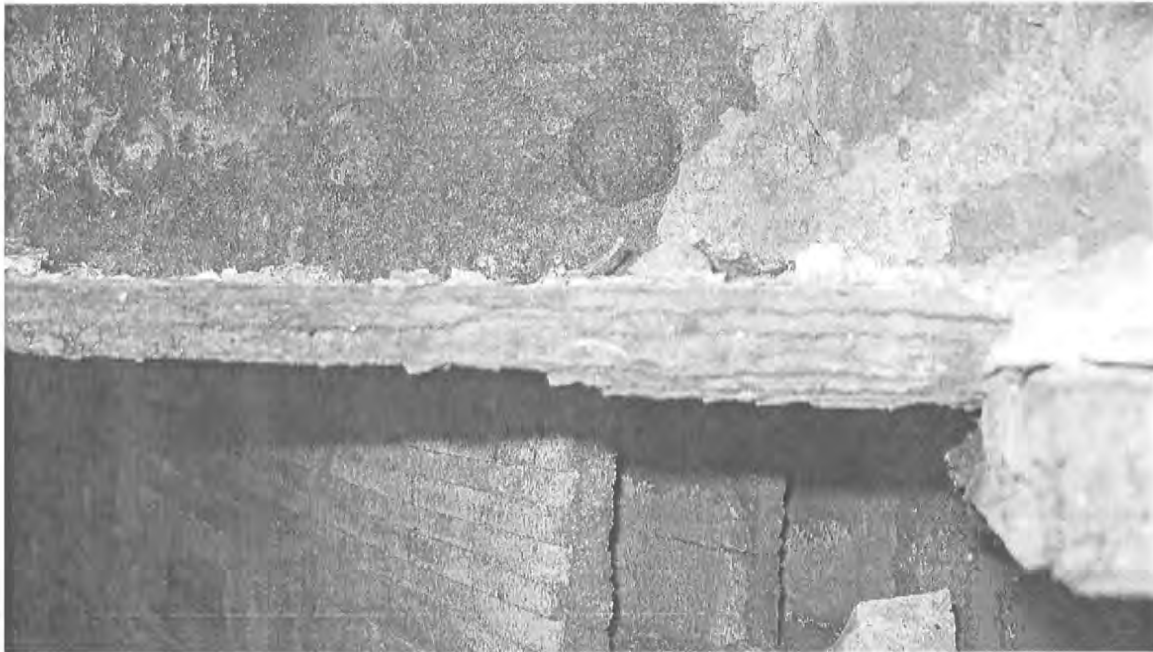
TRUSS "A" AT EXTERIOR COLUMN

Inside the auditorium area we were able to investigate the connection and bearing points for two of eight major trusses type "A" (as indicated in the original plans see Truss Details below). One was in good condition the other not so. Water has caused corrosion at the truss bearing on an exterior column. Easily observed, approximately 1/16" of the 1/2" L flange material has been lost. (As a precaution we generally assume an equal additional amount lost due to field conditions.) This results in a total reduction of approximately 25%. We could not inspect the other connection points at exterior columns and masonry supports and assume 50% them to be in similar condition.

1. Domed truss connection plates and ring at center of dome below cupola.
2. Four of the eight trusses type at exterior columns
3. Eight of the sixteen intermediate truss connections at exterior masonry.
4. Not more than 30% of domed roof purlins and deck.
5. Not more than 25% of sloped roof purlins and deck.
6. Not more than 50% of low roof joists and deck.
7. Not more than 30% of first floor steel and deck.

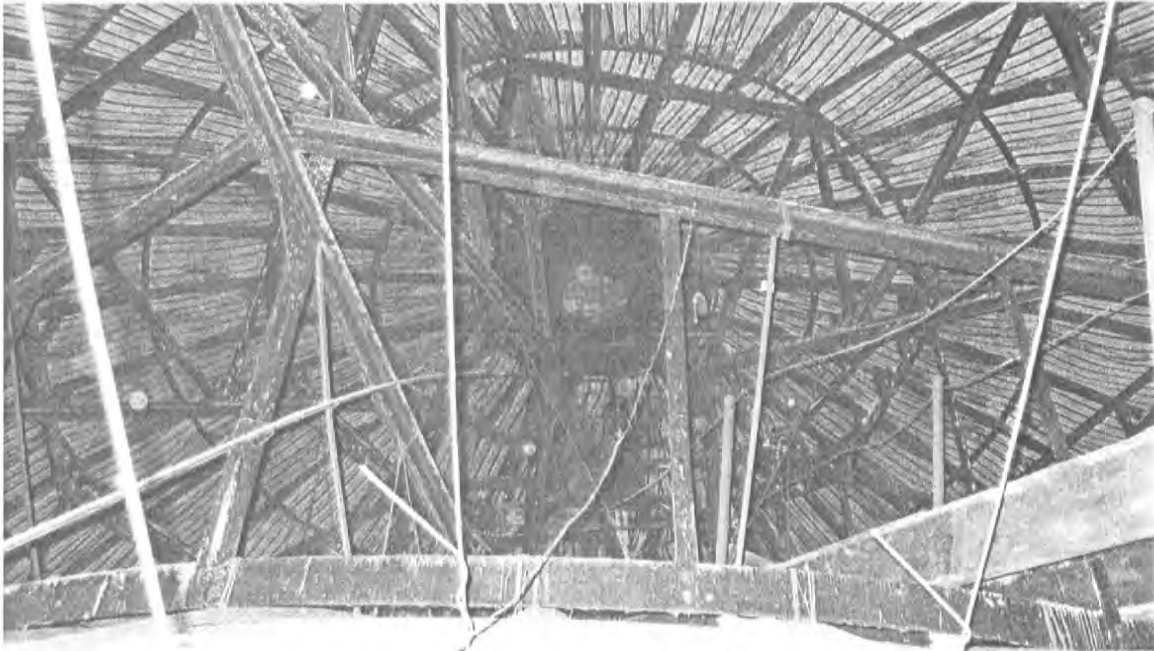
DOMED TRUSS CONNECTIONS PLATE RING

Below the cupola are band and plate connections for the intersecting domed trusses. We observed a good deal of moisture damage as a result of long term water leakage here.

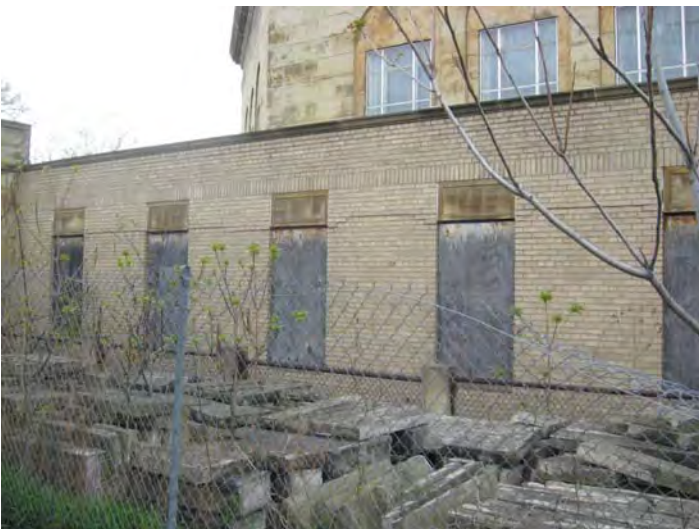
One-story south wing. Note horizontal cracking from corroded lintels swelling to push up masonry above

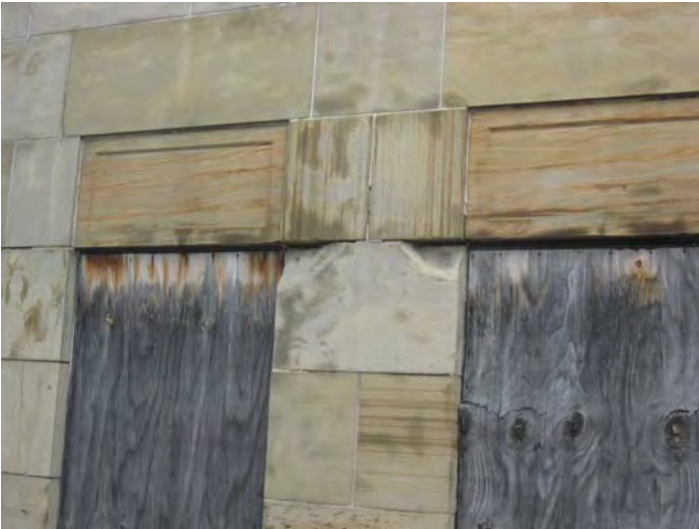
Stone spalling at south wall

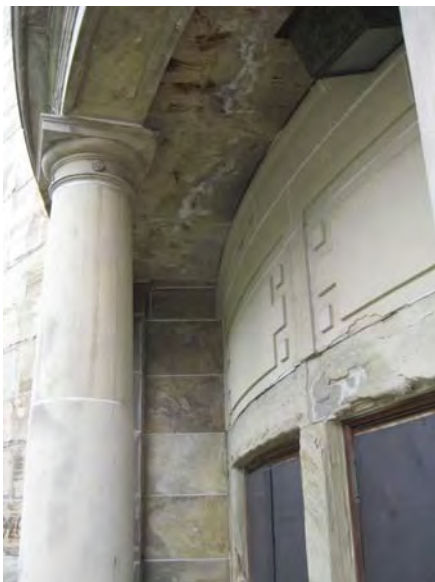
Stone deterioration at west entry

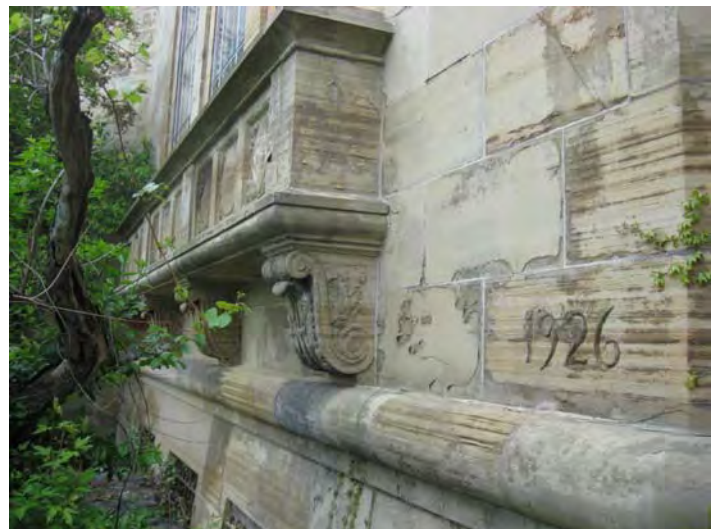
Stone spalling and staining at west elevation

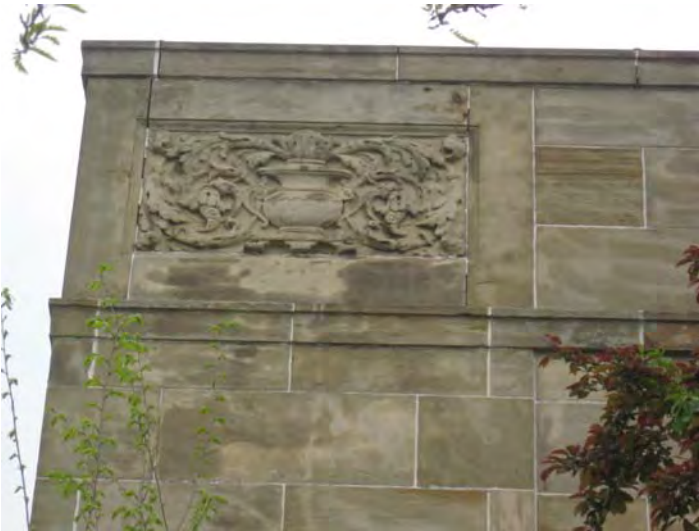
Decorative cartouche, west side of north entry. Note open joint.

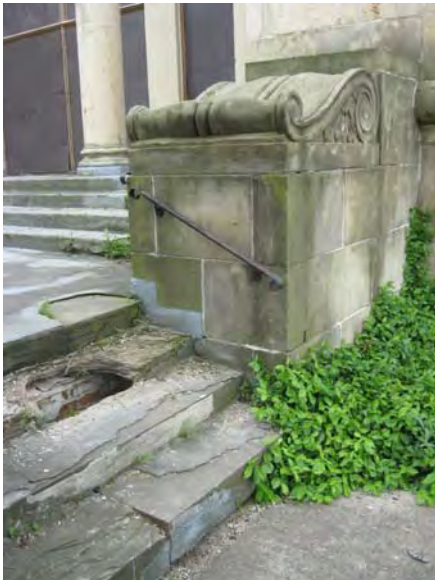
Steps at north entry, deteriorated stone.

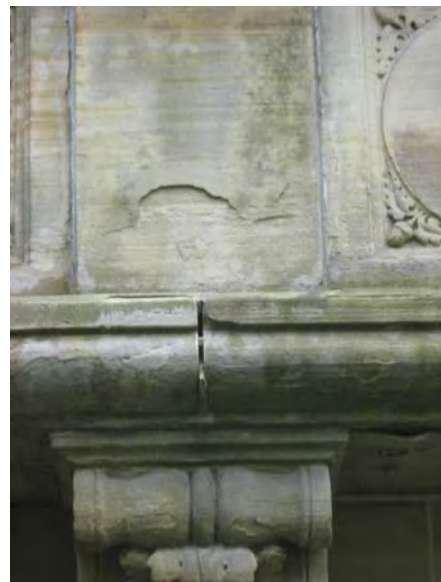
Stone spalling, open joint at north elevation bracket

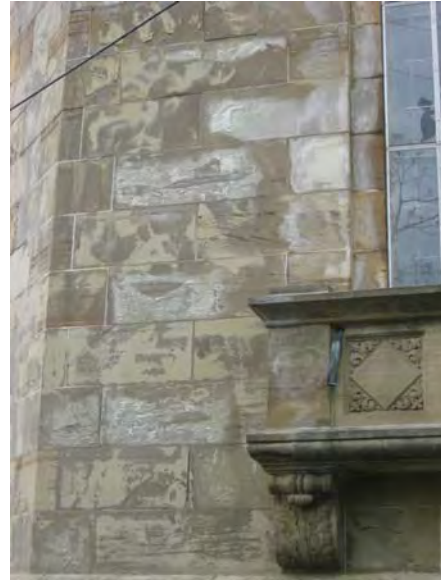
Stone spalling and staining at north elevation

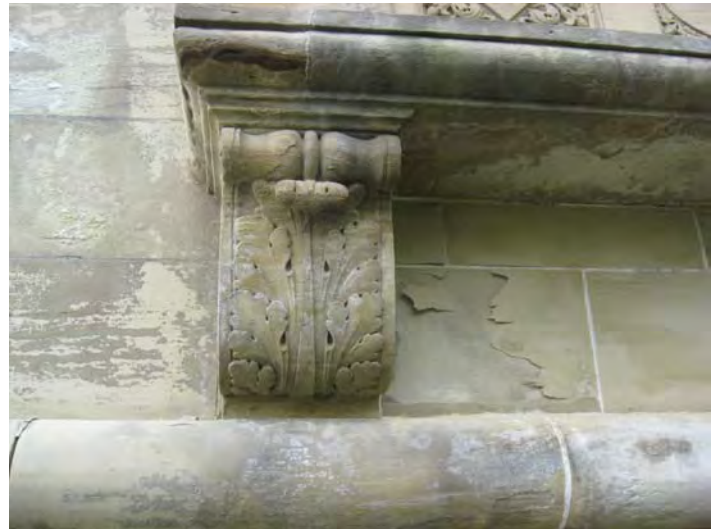
Stone spalling and staining at north elevation bracket

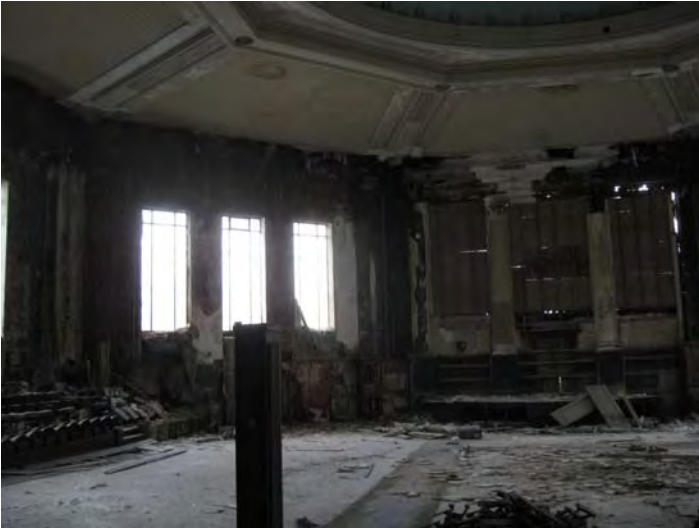
Sanctuary, looking southeast. Wall finishes deteriorated

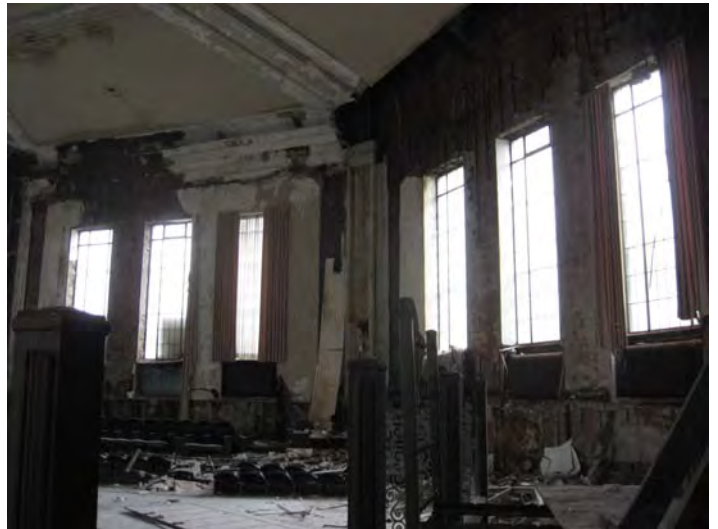
Sanctuary west walls. Wall finishes deteriorated

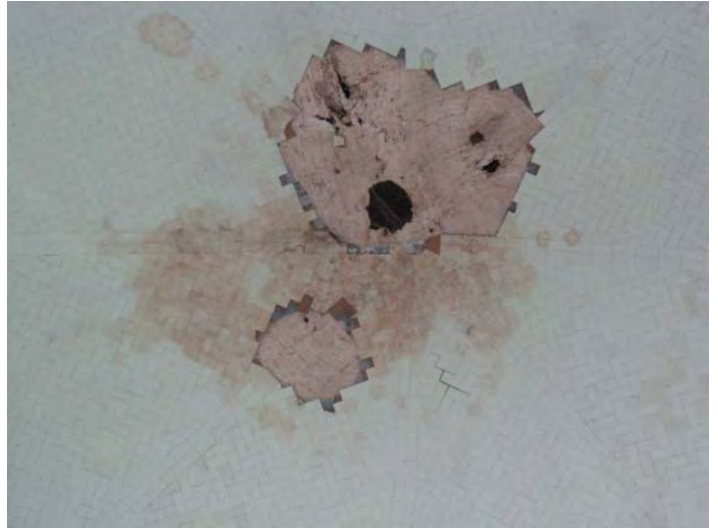
Sanctuary dome. Moisture damage in plaster, acoustic tile missing

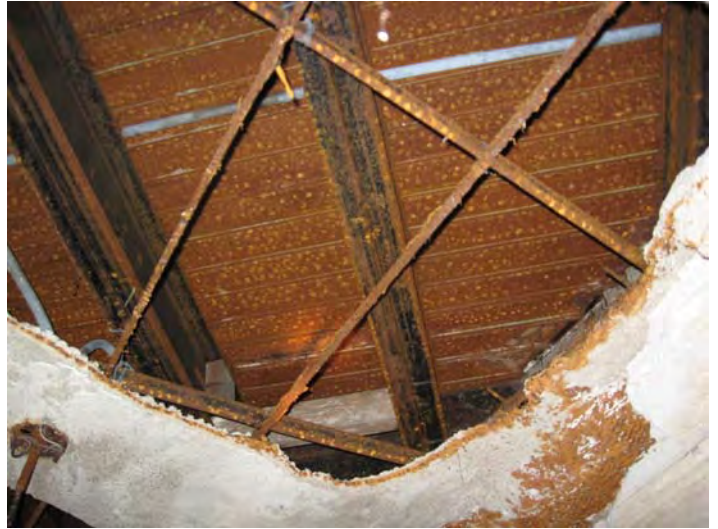
Ceiling and corroded structure. One-story wing south of sanctuary

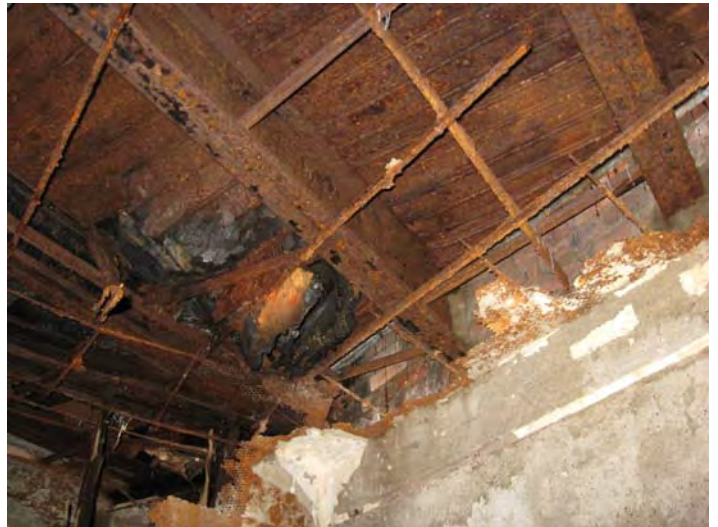
Heavily corroded ceiling structure near west entry. Note failing roof deck

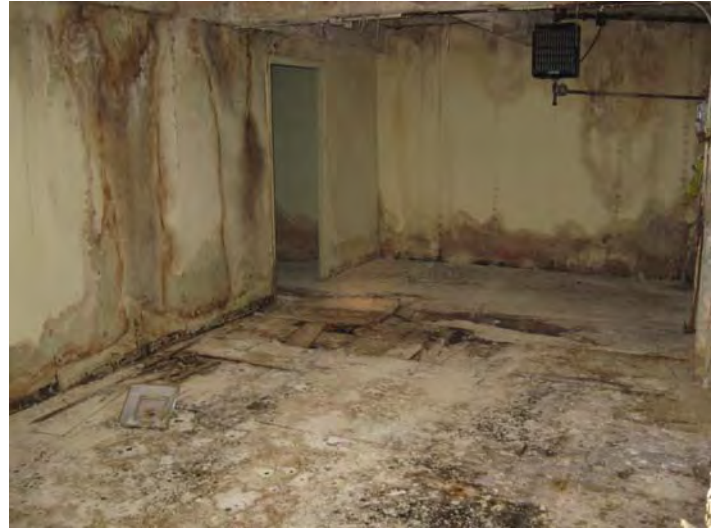
Room under north exterior stairs. Heavy water damage

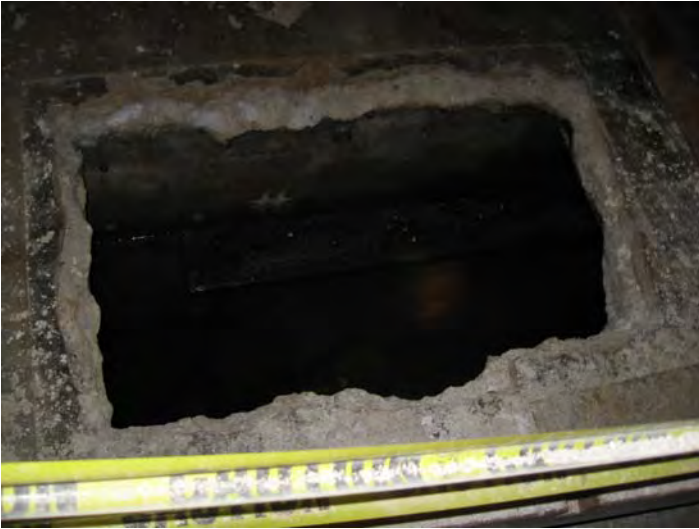
The heaving of the basement floor slab is likely due to freezing of subgrade moisture, possibly caused by leaking subslab piping or the existing underground ductwork which is currently flooded. Excavation of the area would be required to verify the exact cause of the problem.

Flooded underslab ductwork in basement

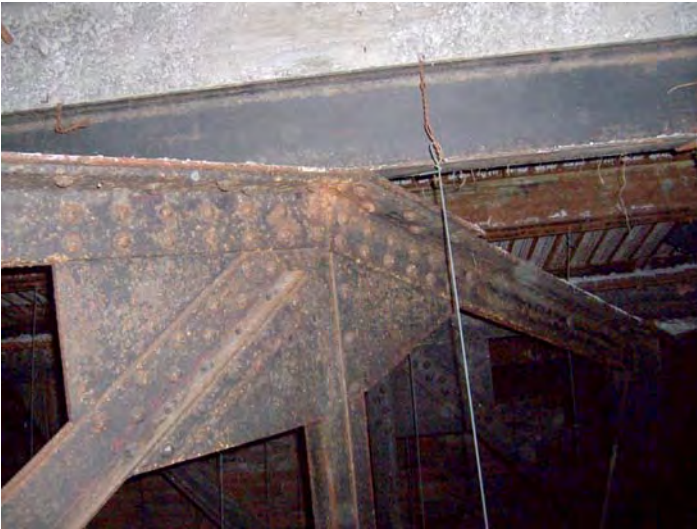
Sanctuary roof truss, very minor corrosion

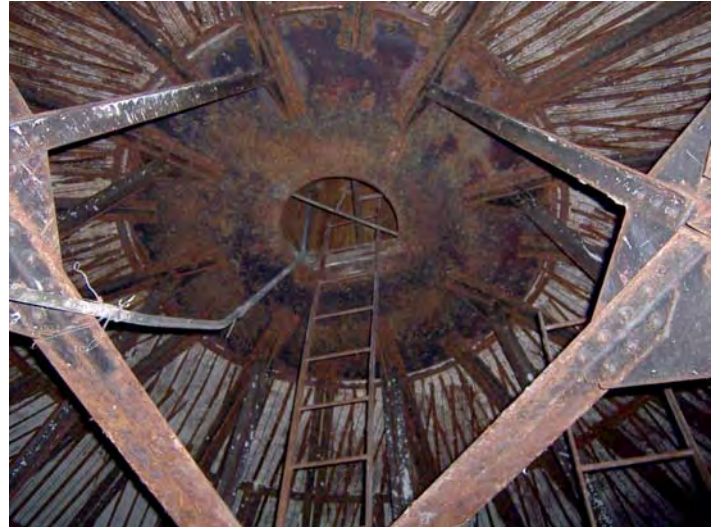
Access ladder to cupola. Heavy corrosion.

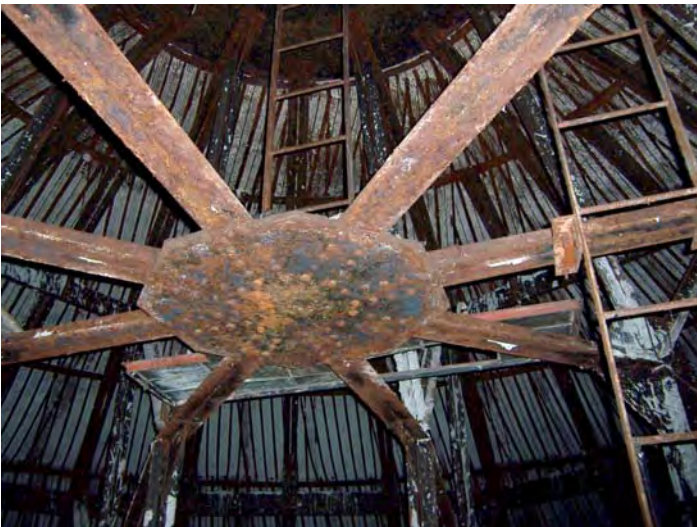
Roof trusses under cupola. Access to these ladders is via rotten wooden platform that appears unsafe to walk on.

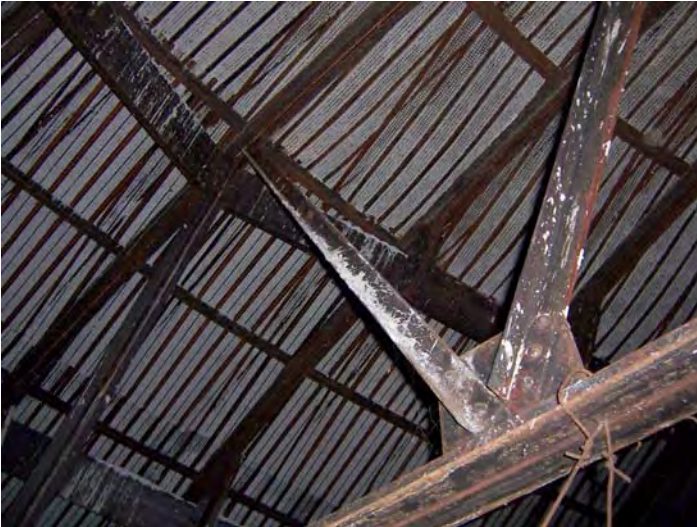
Roof truss under dome, showing some corrosion

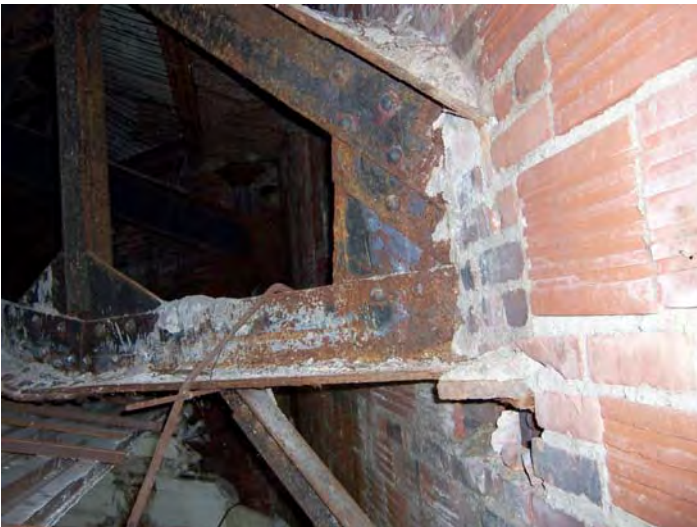
Primary truss bearing at west wall, southern truss. Corrosion observed by steel inspector: 1/16" of 1/2" bottom flange.

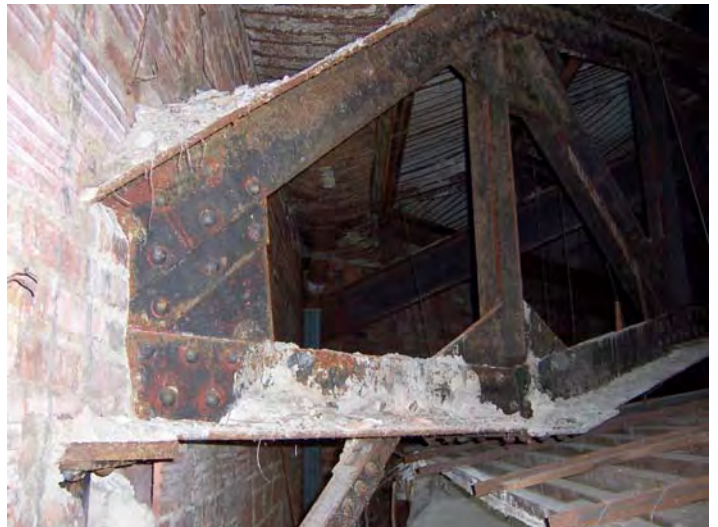
Primary truss bearing at west wall, northern truss. Only minor corrosion observed
