Investigation of Mexican Horse Slaughter Plants approved for export to the European Union

Introduction:

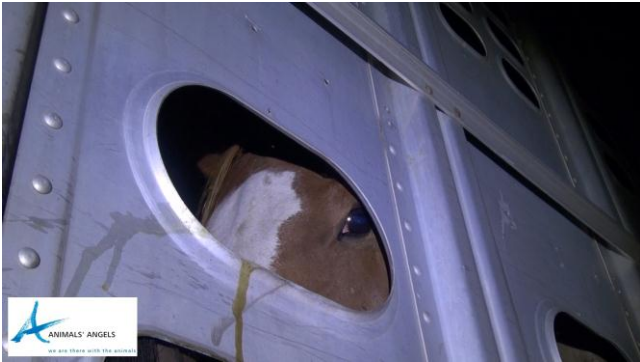
Horse inside trailer

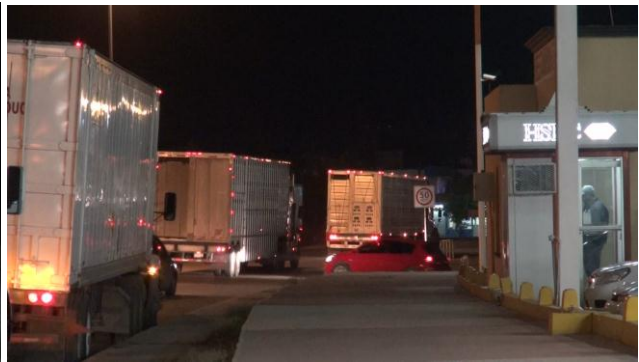
Livestock trucks loaded with horses waiting at checkpoint

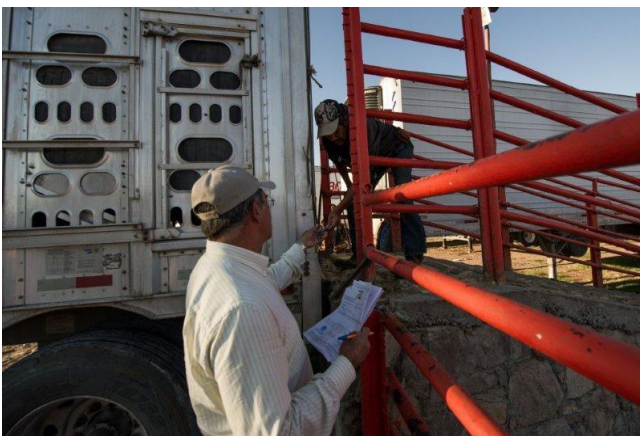
Official checking seal

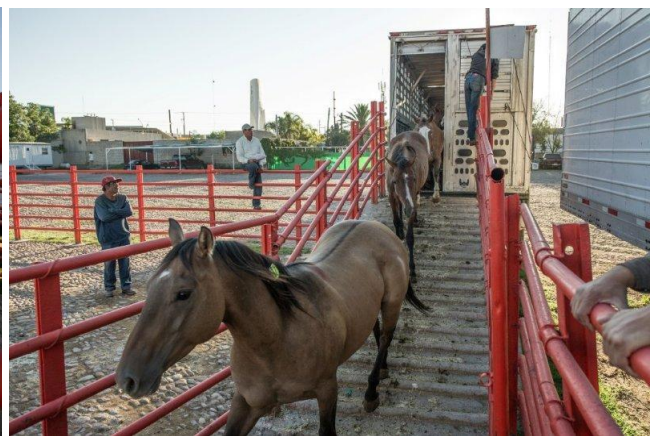
Unloading of US horses

The trucks immediately started to unload, the handling was calm and without any hitting. Several horses were observed limping when they walked down the ramp. Some of the horses were very thin. Many had snotty noses and eyes that appeared infected. Thoroughbreds were noted amongst them as well as several **horses displaying the BLM freeze brand.** The horses were put in a large pen without access to food and water.

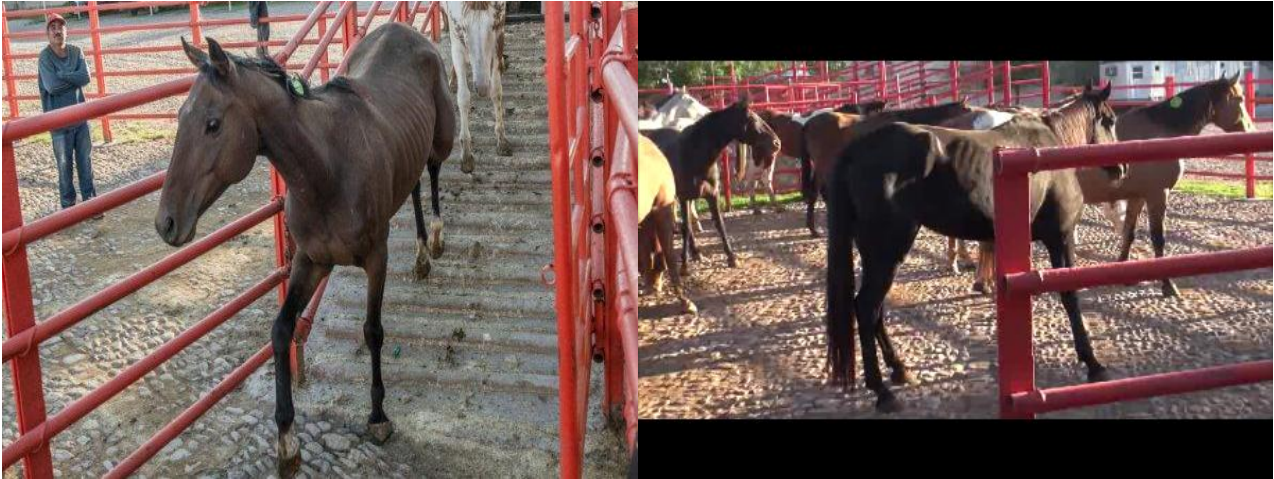
Thin horses

⇒ Many horses from the United States arrived in extremely emaciated condition. Since all horses are checked by Mexican veterinarians prior to import, their condition, shipper and arrival time should be documented. This documentation should be shared with US authorities for enforcement of local animal cruelty laws.

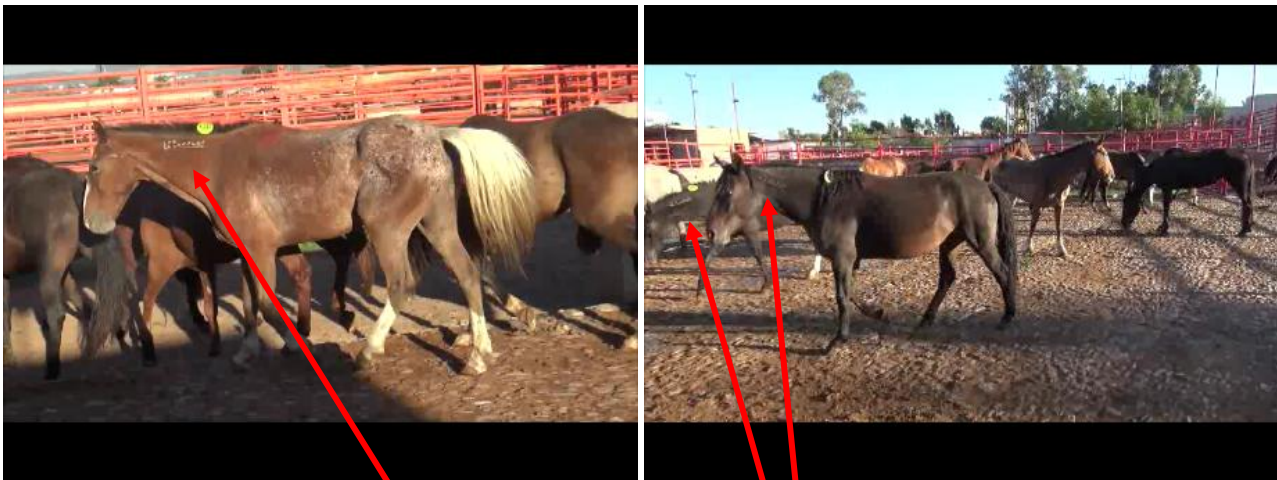
Horses with BLM brands

According to paperwork obtained by Animals' Angels, these horses came from **Triple Crown Ranch in Meeker, OK**. 31 horses were unloaded from the first trailer, 27 horses from the second trailer. Nothing on the owner/shipper paperwork indicates that any BLM branded horses were among the ones loaded, despite the fact the shipper is required to enter this information on the owner/shipper certificate. Additionally, the information regarding sex, breed and age of the horses in different Triple Crown Ranch shipments is identical on multiple owner/shipper certificates, **which proves that the paperwork has been falsified.**

⇒ Evidence obtained by Animals' Angels shows that the paperwork used to identify the horses in the individual shipment is falsified and not reliable. Without proper identification of each horse it can't be determined where the horse came from and what kind of drugs it has been given.

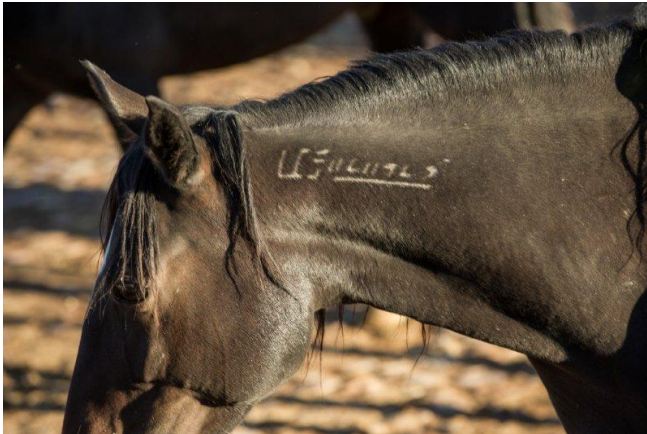
Animals' Angels was able to identify two of the BLM branded horses found in the shipment:

Freeze brand #: 06181485 and 00832889
Signalment key #: HF1AAAHB and HM1EEEFIP

BLM horse

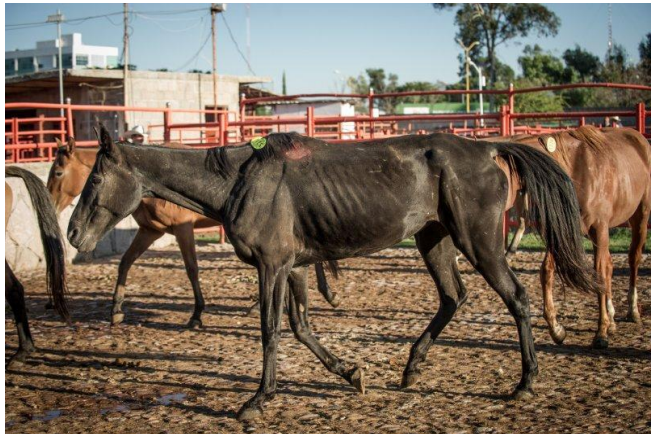
severely emaciated horse with US slaughter tag

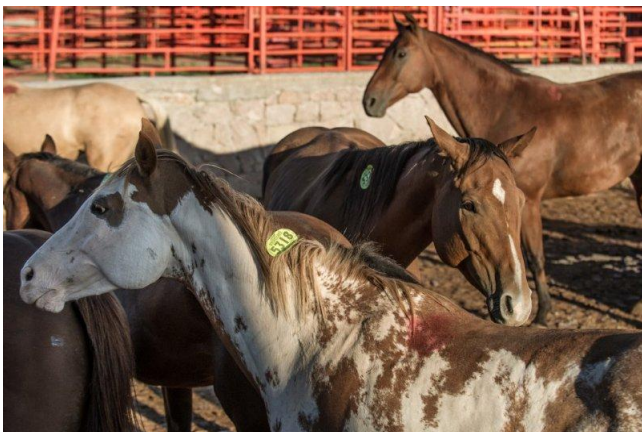
US horses in pen area

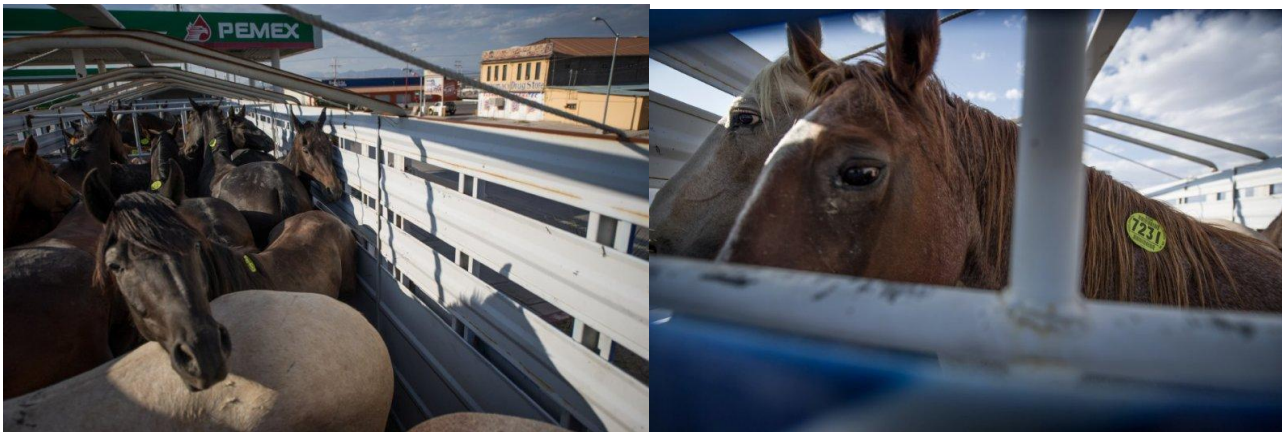
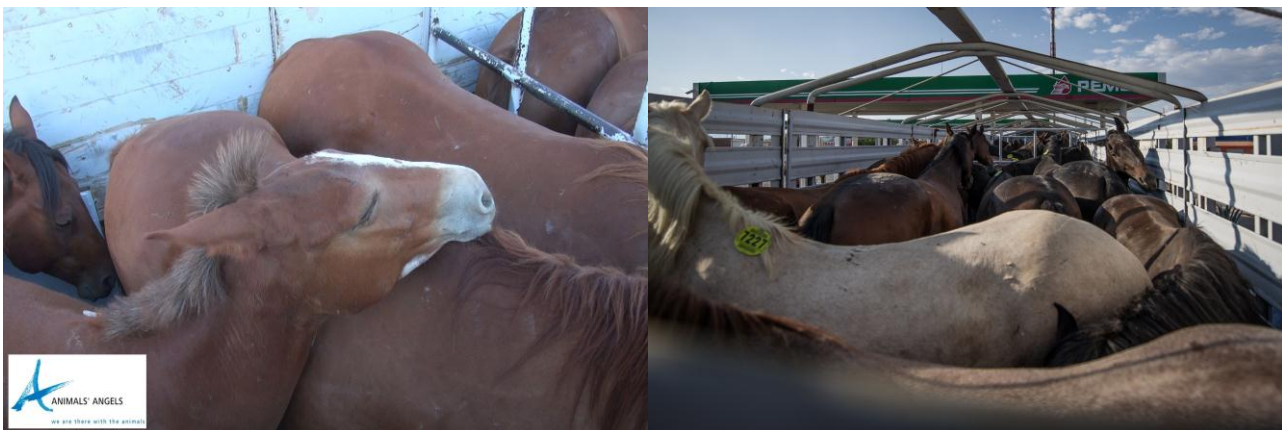
The first truck with horses crossed through the border at 5:00 pm. The white Freightliner (Transport Company: Autotransportes des Conchos; DOT 0556446) pulled one of the newer, open roof trailers, which offer no protection from sun or rain. Investigators documented the condition of the horses inside the sealed trailer. Two dividers were placed inside the trailer, segregating horses into three groups. The compartments were quite crowded and the horses were observed biting each other and fighting for space.

⇒ Horses are transported to the plant in open roof trailers which offer no protection from the desert sun.

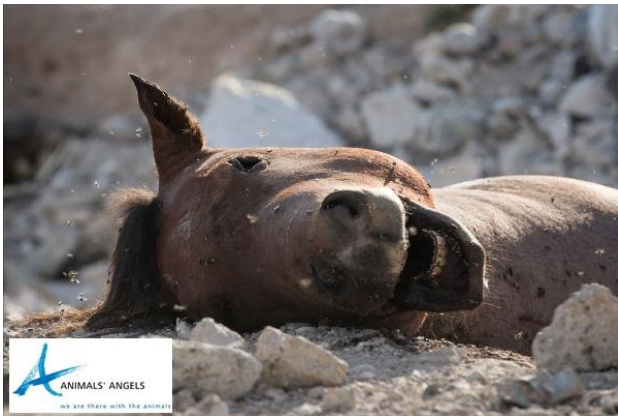
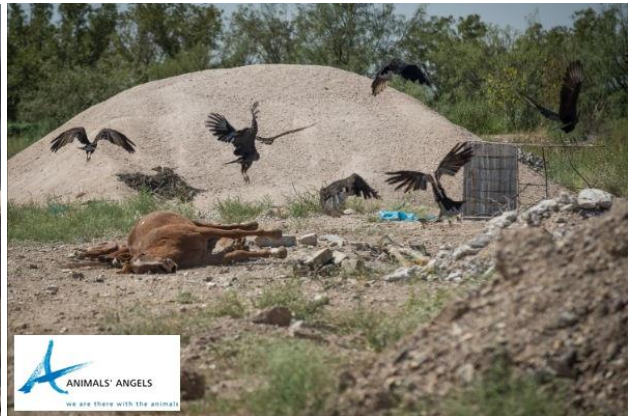
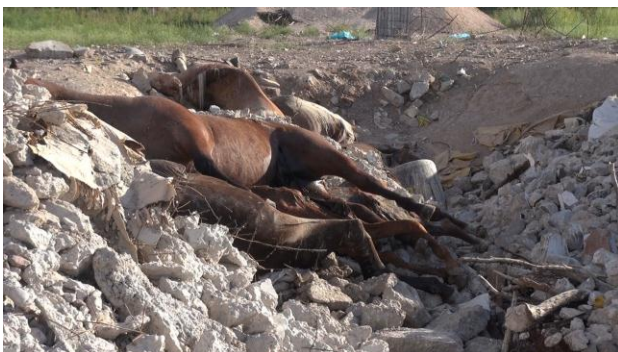
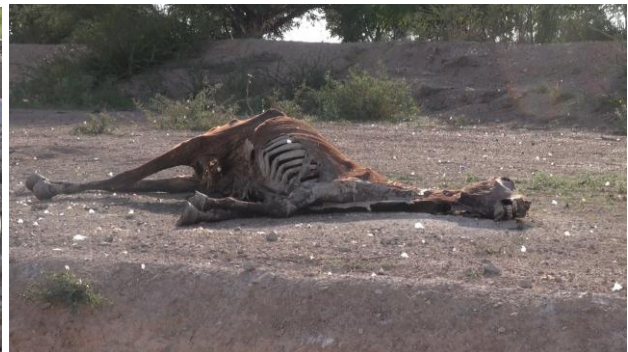
Investigators immediately noticed a death pit on one side of the property. Several horses had been dumped there and left uncovered for the vultures to eat. They were in various stages of decomposition. No bullet holes were visible. Horse parts and bones were scattered throughout the area, likely dragged away from the pit by scavengers.

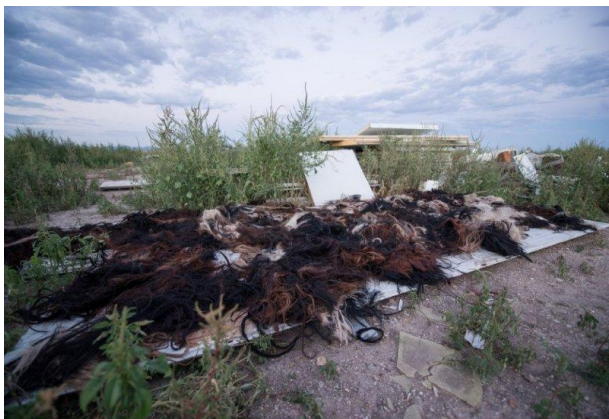
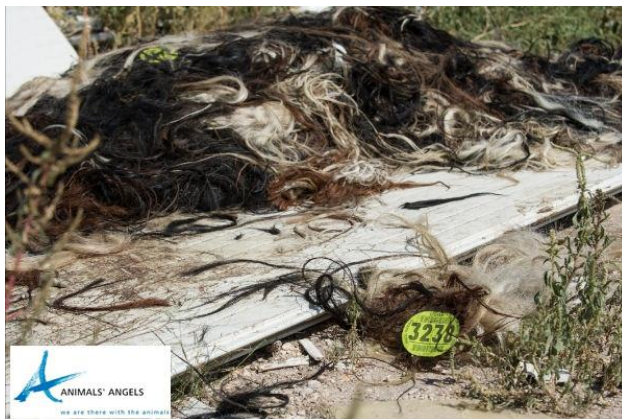
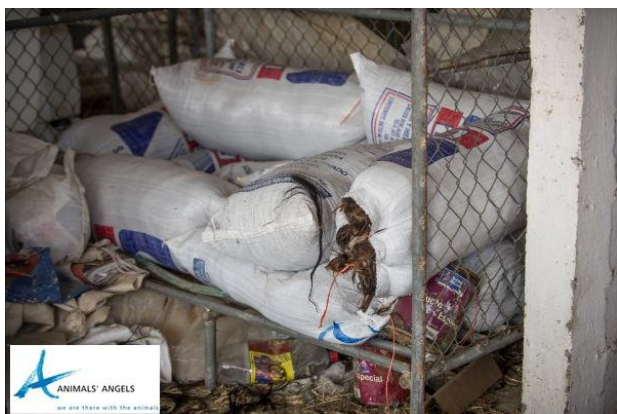
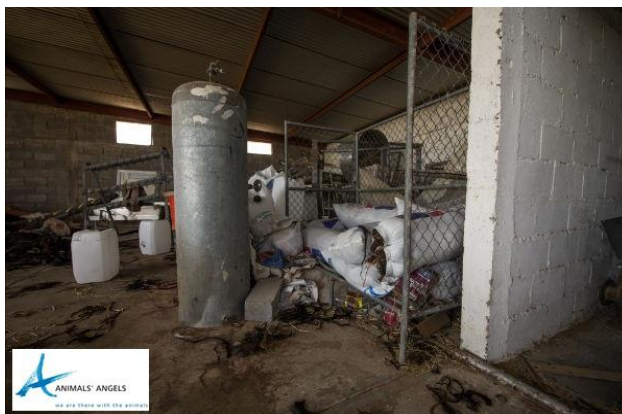
Investigators were able to access the holding area of the plant. On one side, a large amount of horse tails and horse hair was placed on wooden planks for drying. Some of the hair had USDA slaughter tags still attached. The dried horse hair was packaged into feed sacks, which were stacked up along a wall.

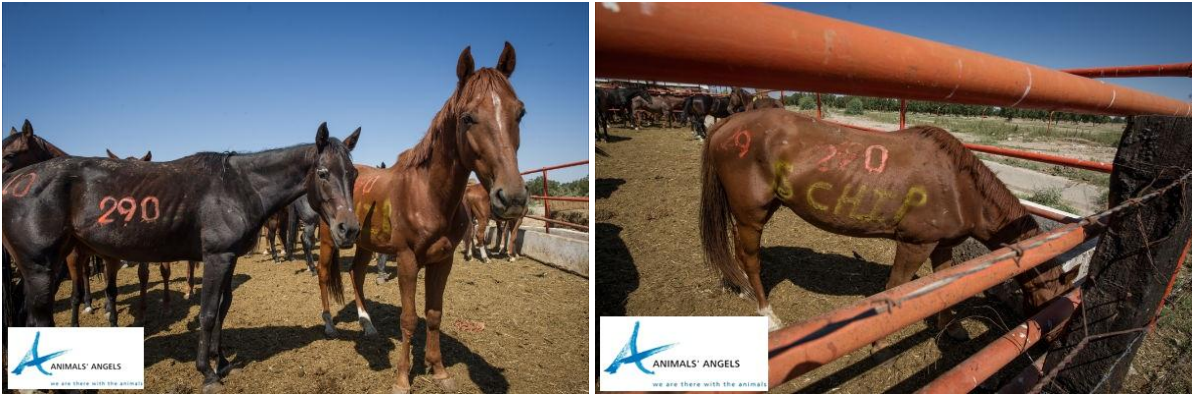
The holding area is quite substantial with numerous pens and concrete feed troughs along its side. Not all of the pens provide shelter from the desert sun. Several horses inside the holding pens were very thin. Investigators observed the horses being fed hay one time during their observation, however, the feed troughs were often documented empty. Several pens did not have access to water at all times.

Thin horses with large numbers/letters

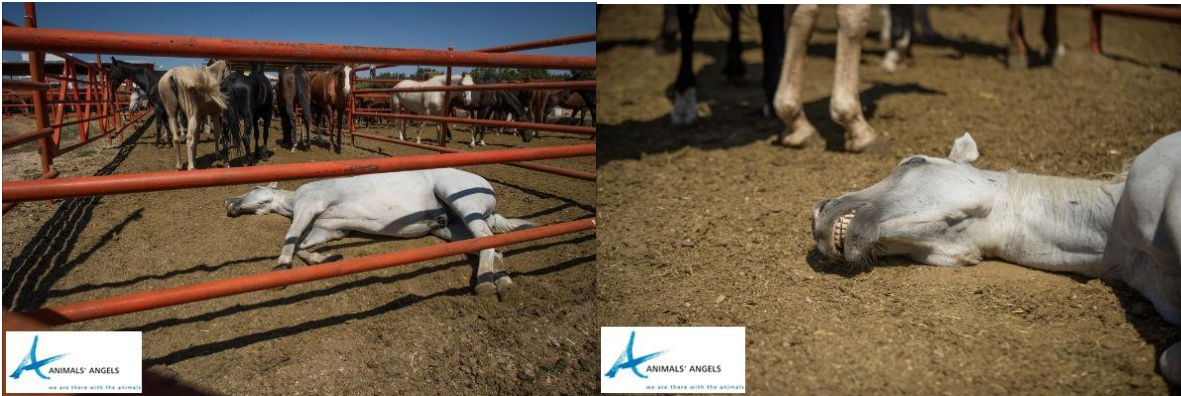
Many had large red, three digit numbers or letters painted on them. Lots of USDA slaughter tags were visible. In one of the pens, investigators found a downer horse. He did not move even when it was approached by the investigators, his mouth was open and only shallow breathing was visible. Investigators did not see any plant workers check on the horse.

Horse being down inside the pen area

wall of the chute obtaining a bleeding face injury. A non-ambulatory horse was observed which did not receive immediate attention.

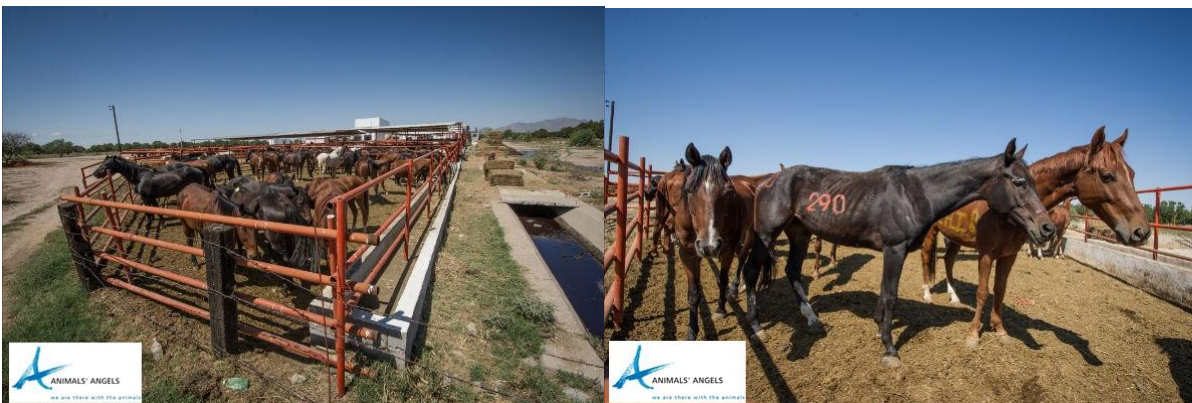
Thin horses in pens with no shelter and empty feed troughs

⇒ Observations at the Camargo plant as well as the Aguacalientes plant show that horses did not have access to water at all times.

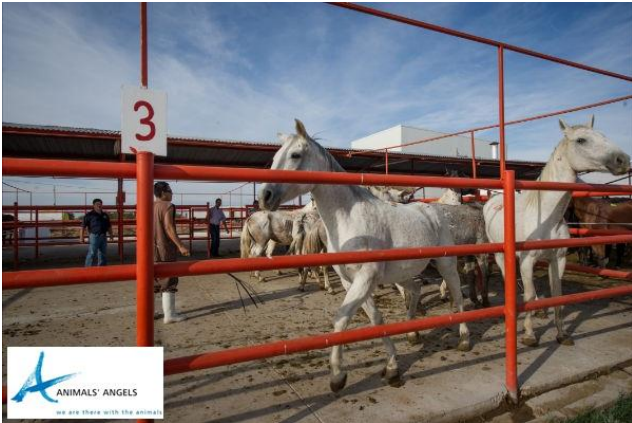
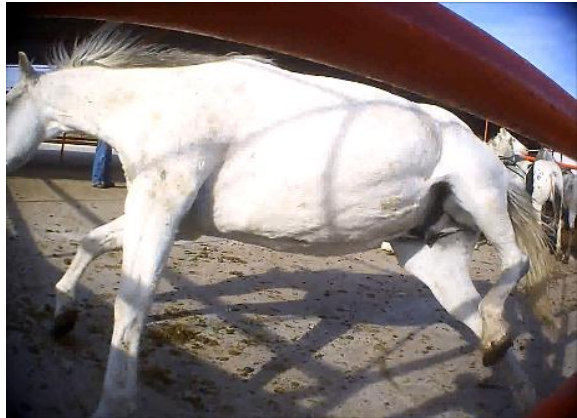
Later, investigators filmed a group of US horses who were moved from the pens to the plant to be slaughtered. Workers moved them with the help of plastic sticks with multiple, split ends. The overall handling was calm with the exception of one worker who was seen impatiently whipping horses in one of the pens. All pens close to the plant have slippery, concrete flooring with no bedding and several horses were observed sliding and falling down with full force.

⇒ Observations at the Camargo plant show that horses slip and fell during movement to the plant due to slippery surfaces. Additionally, one horse panicked after being showered and tried to escape over the concrete

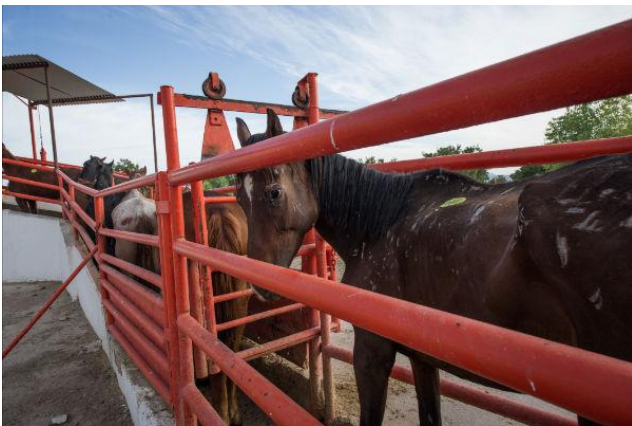
Horse in chute leading to plant entrance

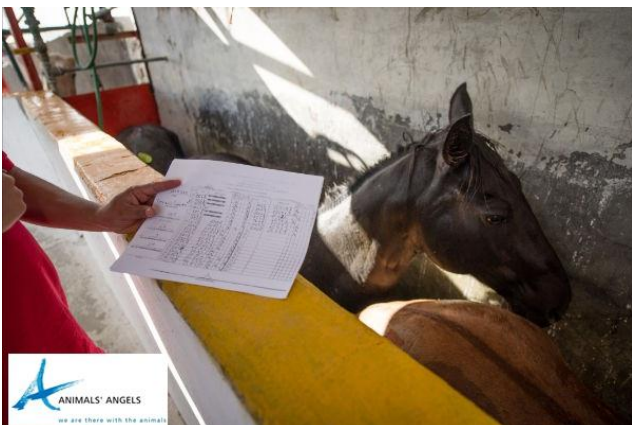
Last paperwork check

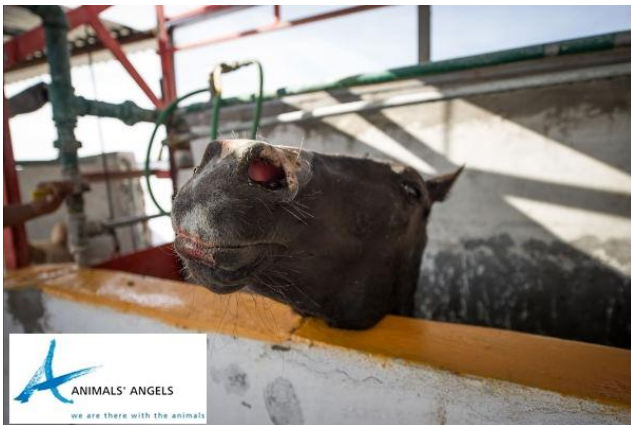
While being in there, the horses had to pass through a shower that rinsed them off before they entered the plant. Several of the horses were terrified.

Terrified horse

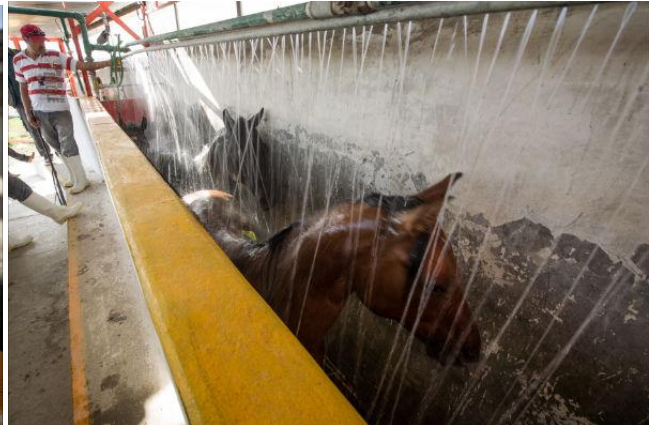
Shower area

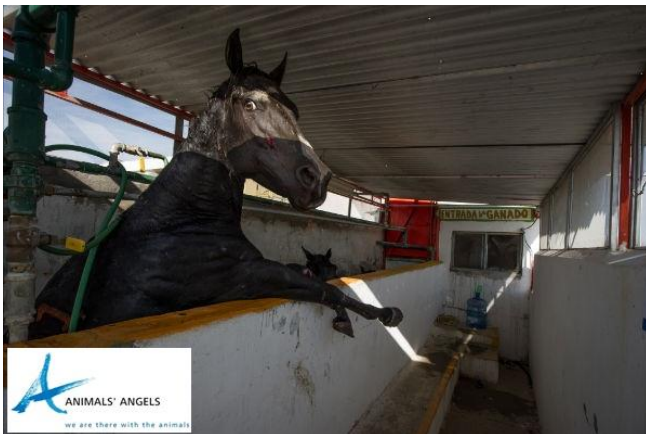
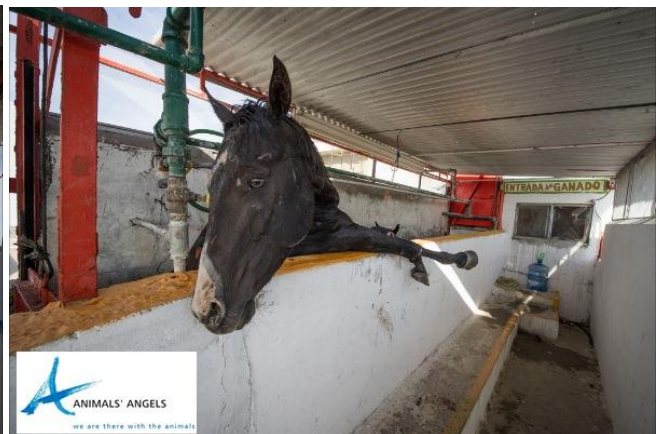
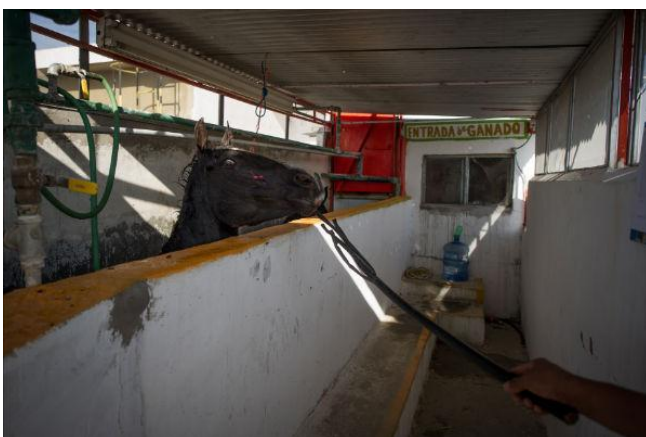
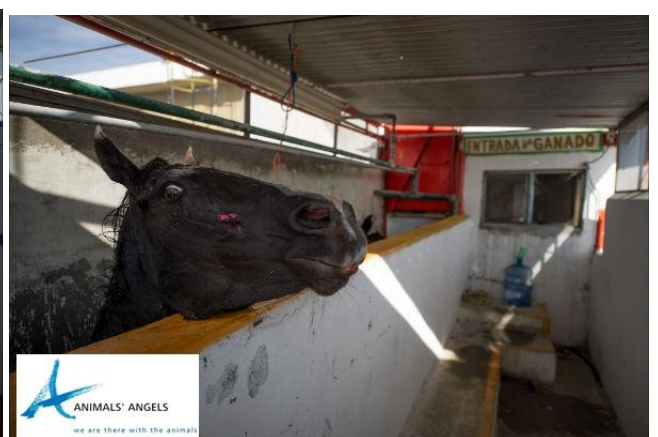
One stunning black horse with a white blaze panicked and tried to jump the concrete wall. Workers hit him and forced him to back down, but he injured himself in the process and obtained a bleeding injury on his face.

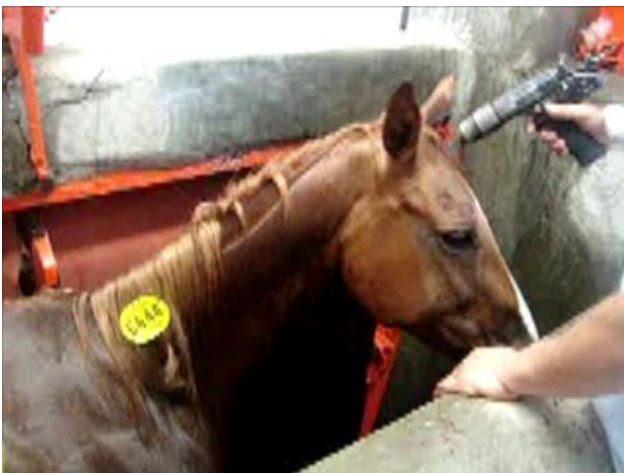
Video footage obtained of the slaughter of two US horses inside the Camargo plant confirms that horses are stunned with a captive bolt prior to slaughter. In both cases, the captive bolt was placed directly on the horse's forehead when fired.

Horse being stunned with captive bolt

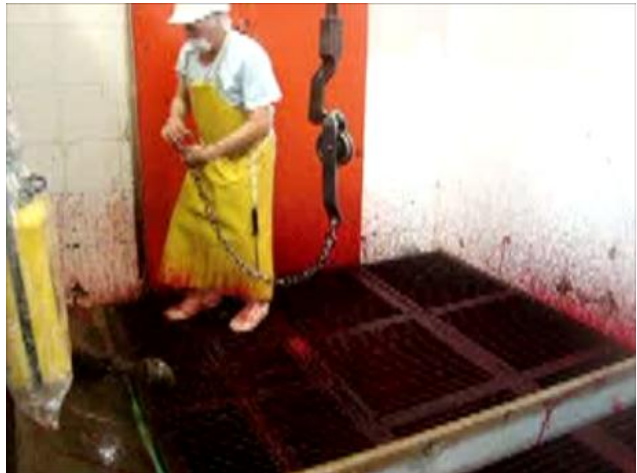
Worker attaching chain to hind leg

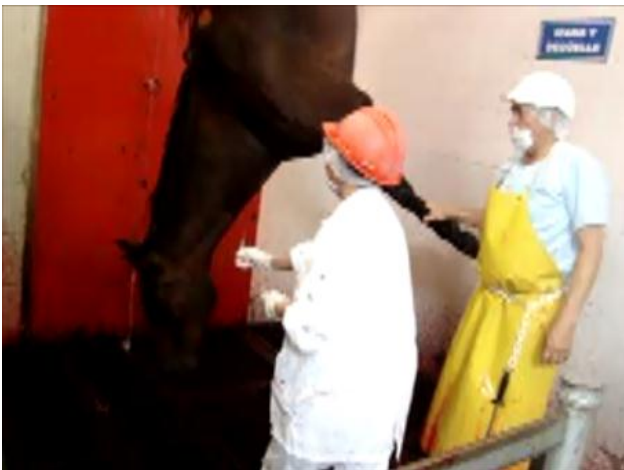
Worker drawing blood

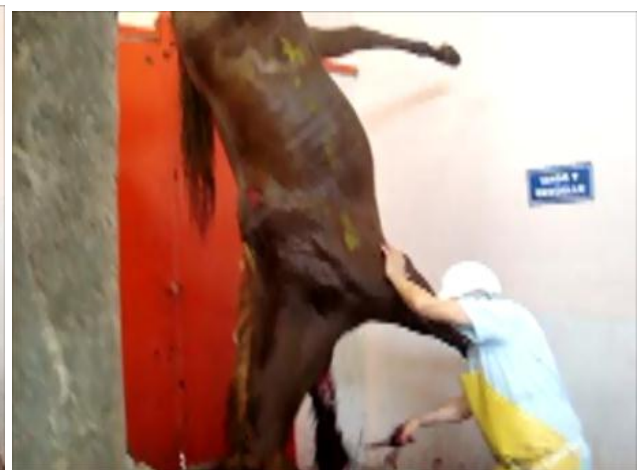
Worker bleeding horse
