## NASAL CAVITY CT DIAGNOSTICS

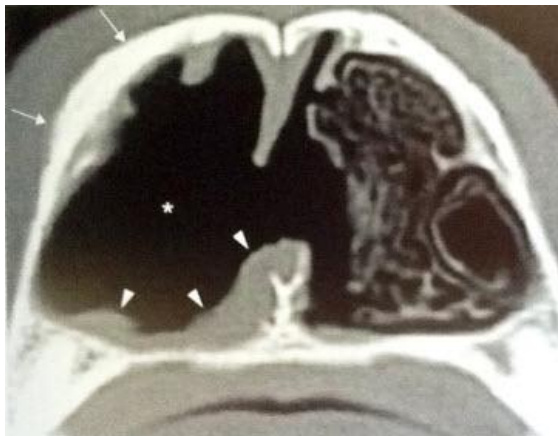
Figure 1

These transverse CT images show the nasal cavities in four dogs with nasal aspergillosis. (Figure 1) There is complete destruction of the nasal turbinates in the right side (asterisk\*) with extension to the contralateral side through the nasal septum. The nasal mucosa is thickened ventrally (arrowheads). The maxilla is thickened on the right side (arrows). (Figure 2) There is severe destruction of the nasal turbinates in the right nasal passage (asterisk\*). There is mucosal thickening dorsally and medially, and maxilla bone reaction (arrow). (Figure 3) There is partial destruction of the ethmoturbinates in the dorsal lateral aspect of the right nasal cavity (asterisk\*). There is mucosal thickening surrounding the destroyed area (arrowheads). (Figure 4) There is a large amount of soft tissue/fluid density in the right nasal cavity (asterisk\*). There is severe turbinate destruction. The palatine bone and the maxilla are thinned (arrows).

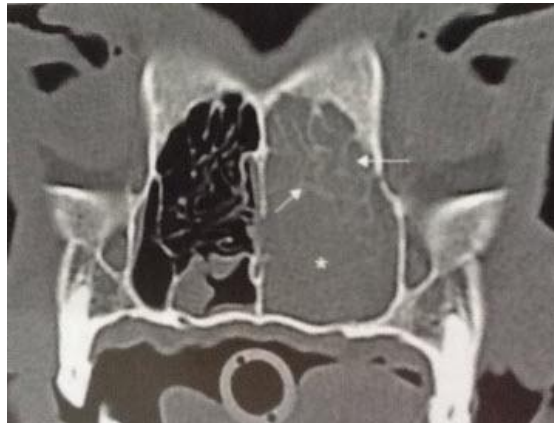
Adult dog with a nasal adenocarcinoma. A transverse CT image shows a completely obliterated (asterisk\*) left nasal cavity. The ethmoturbinates are destroyed in the ventral part of the cavity while some are intact dorsally (arrows).

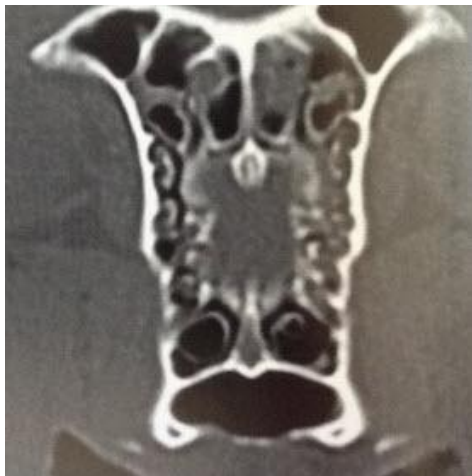
*Figure 1*

Adult dog with non-specific rhinitis. Transverse CT at the level of the caudal parts of the nasal cavity. These sections of the nasal cavity show diffuse, randomly distributed bilaterally increased density of the nasal passages due to mucosal swelling and fluid accumulation. There are no bone lesions. (Figure 1)  
Transverse CT image at the level of the mid nasal cavity. (Figure 2) An adult dog with non-specific rhinitis. Transverse CT images at the level of the rostral nasal cavities. (Figure 3)

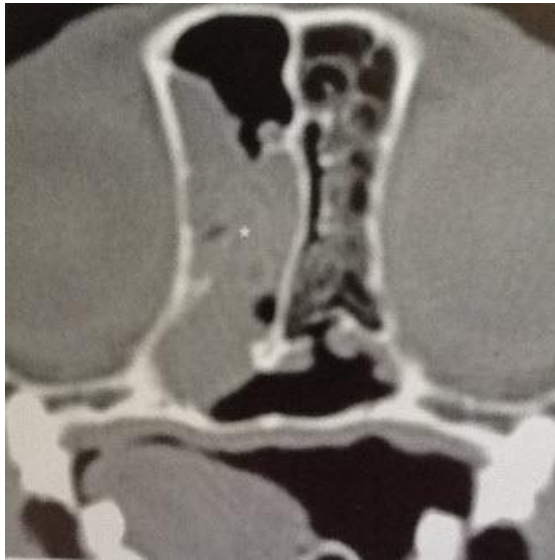
*Figure 1*

Transverse CT image of a young cat with a nasal polyp. The right nasal cavity is obliterated by a soft tissue density (asterisk \*). The remnants of the ethmoturbinates are still visible. The nasal septum is displaced to the left. (Figure 1) The right frontal sinus is divided into a medial and lateral compartment. The latter is filled with fluid (asterisk\*). (Figure 2) There is malformation of the of the cribiform plate (arrows) and a small amount of fluid in the right frontal sinus (asterisk\*). The frontal crest is deviated to the left (arrowheads). (Figure 3)
