Demolition Profile

Newton North High School

Costello Dismantling Co., Inc.

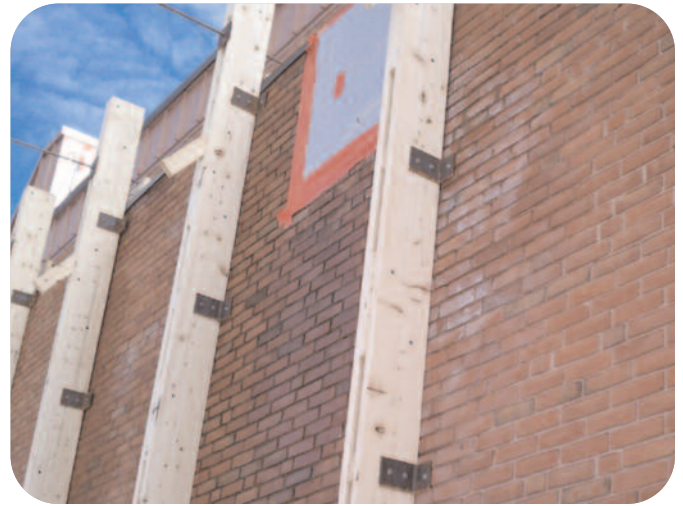
Engineering Spotlight

The peer-reviewed engineering plan for the bracing system allowed the brick façade to be used as the critical barrier for asbestos removal, rather than an extremely costly tenting system. This innovation provided a savings of two million dollars to the city.
-

To prove that the system would properly work and not create a safety or public health risk, the engineering plan had to account for positive and negative wind load distribution, vertical loading, horizontal shear, as well as numerous and varied types of bending, compressive and elastic forces.

Our structural engineer, project manager and entire staff spent countless hours poring over the problem for a solution. The solution evolved and was refined many times into a system of exterior supports that braced the brick façade against the interior floors. The supports would be installed before interior masonry block removal, then removed and reinstalled as each floor of a zone was abated. This also allowed the brick façade to be recycled rather than disposed of as asbestos-containing debris, a savings of at least 25% of disposal costs.

Weeks of engineering--taking into account support loads, wind loads and the myriad of forces at play--produced design documents and calculations that were submitted for peer review and finally this extremely unorthodox approach was delivered to the regulatory bodies. After being granted a trial of the method, MassDEP enthusiastically
