Former Fifth Church of Christ, Scientist

11623 Lake Avenue
Cleveland, Ohio 44102

Facility Assessment

October 1, 2009

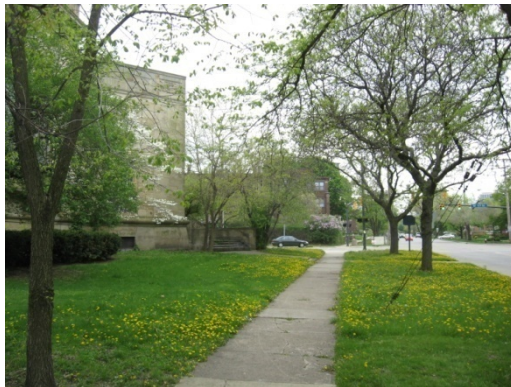
Site: Steps at the front entrance are deteriorated at some locations and require repairs. Areawells at the perimeter of the building have some trash and debris, but drains appear to be functioning enough to prevent flooding.

Existing Landscaping
