Investigation of Mexican Horse Slaughter Plants approved for export to the European Union

Introduction:

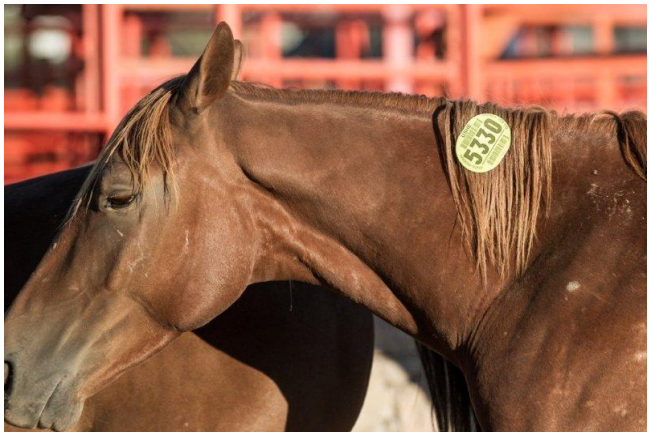
US horses in pen area

Investigators were informed that the horses would not be slaughtered right away, but kept in the holding area for a while. Inside the holding area many horses with green USDA slaughter tag were visible. Several were extremely emaciated.

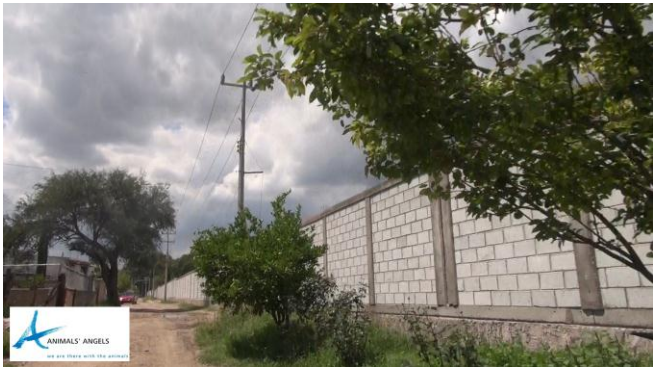
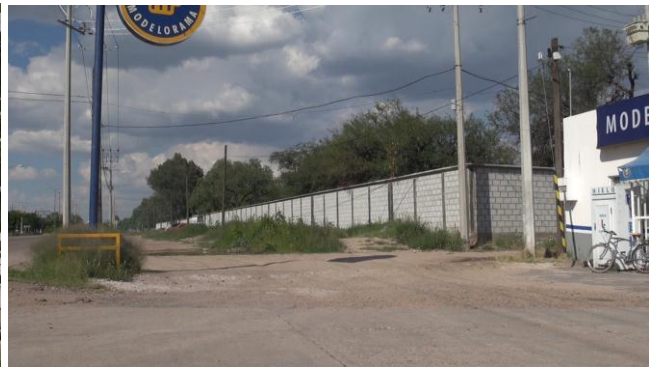
The location has changed since Animals' Angels last visit; a solid wall has been erected around the premises, which completely blocked the view of the unloading pens and the plant. A new security gate has been built with an office next to it.

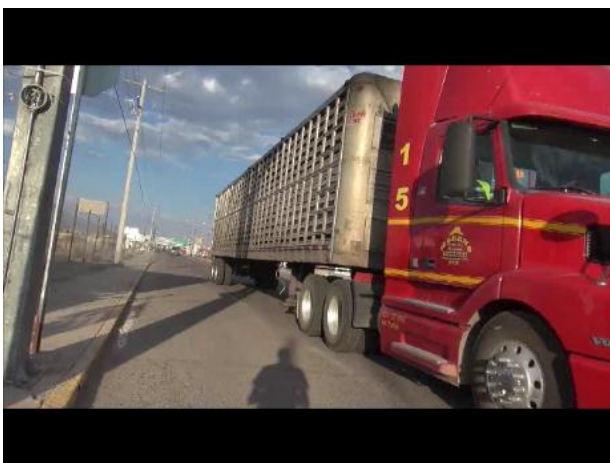
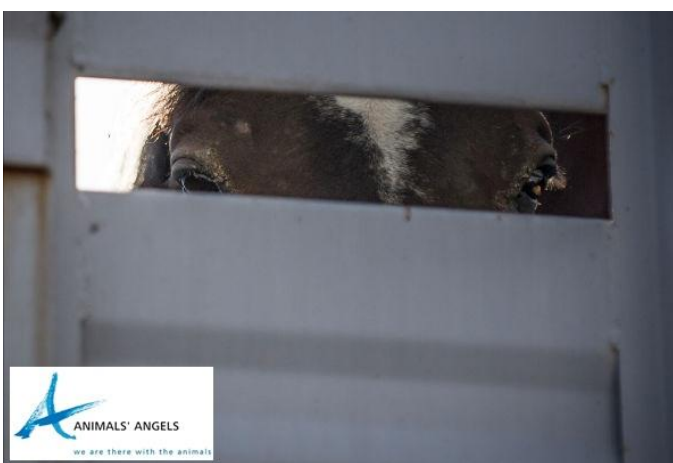
The next truck crossing through was a red Volvo pulling a Silver Star single deck trailer. (Transport Company: Moreno; DOT 2327265). Investigators documented as many horses as possible before being forced to stop filming. They then decided to head to the Camargo slaughter plant.

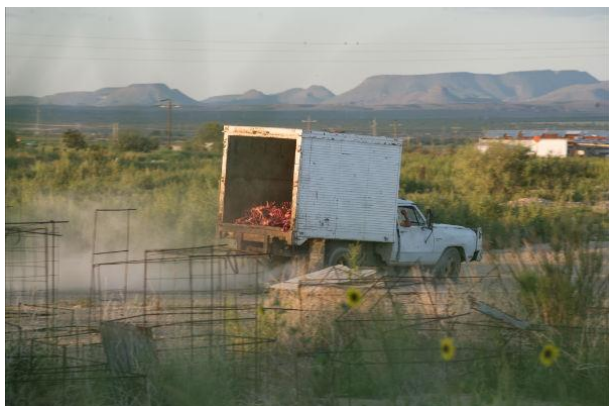
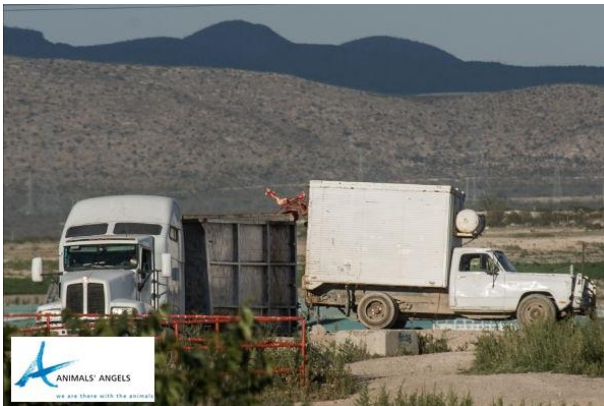
A small truck loaded with carcass parts left the plant and was observed loading them into a bigger truck down the road at an empty building. After the exchange, both trucks returned to the plant. It is unclear why they did not load on the slaughter plant premises.

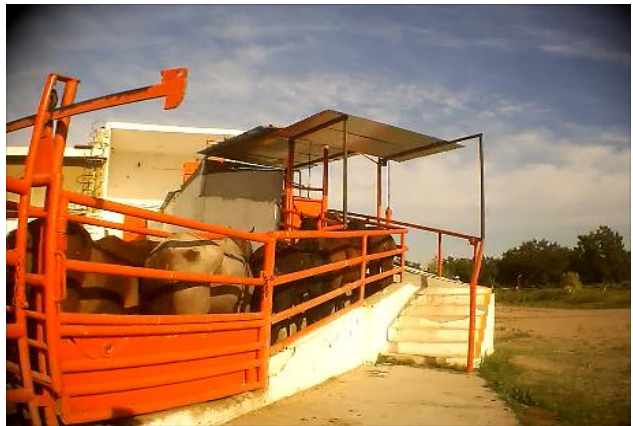
Horse in chute leading to plant entrance

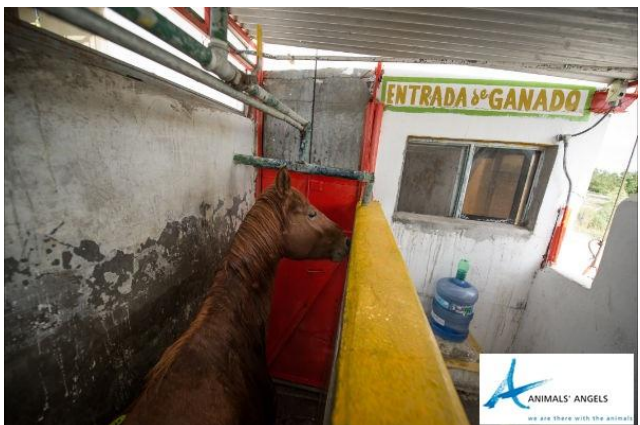
Last paperwork check
