Fifth Church of Christ - Facility Assessment

11623 Lake Avenue

City Architecture Job No. 09033

October 1, 2009

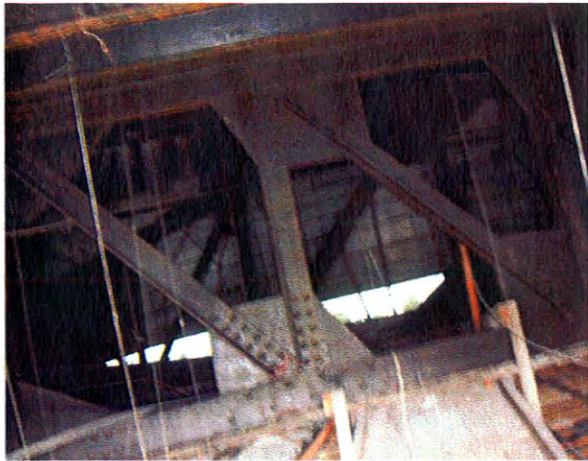
i. Riveted Truss Connections

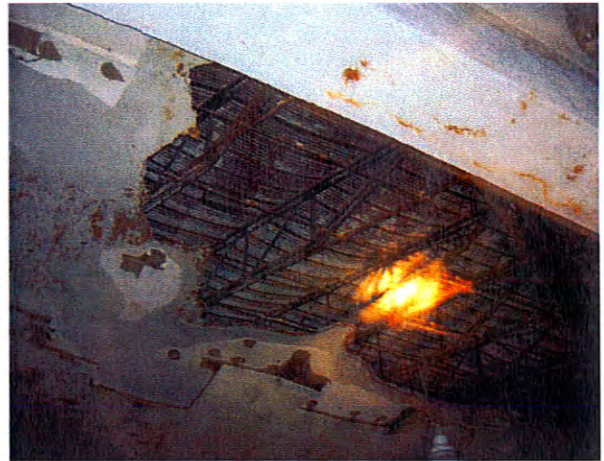
5. Above grade 1st floors are supported either by 9" bar joists or back-to-back channel and are also in areas severely corroded.
6. Masonry is cracking outside adjacent to steel lintels, primarily along the southern wall of the one story portion of the building. The existing lintels are corroding and expanding, jacking up the masonry parapet above.

First Floor Joist

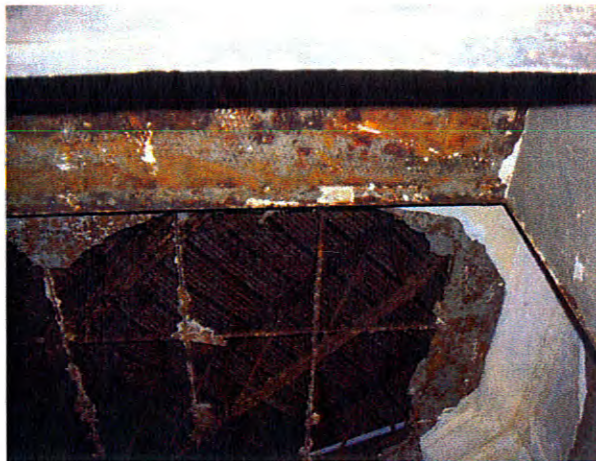
First Floor Joist

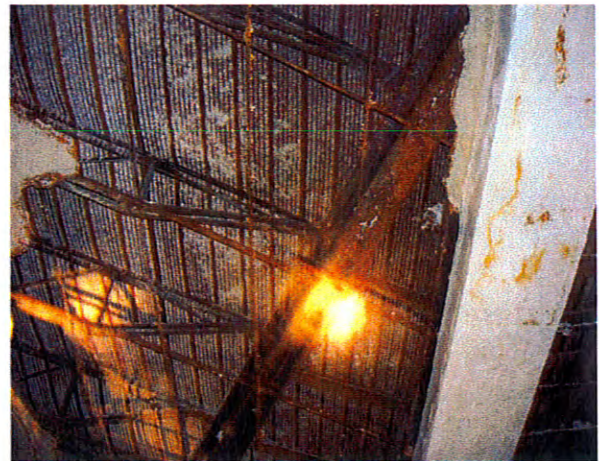
First Floor Joist

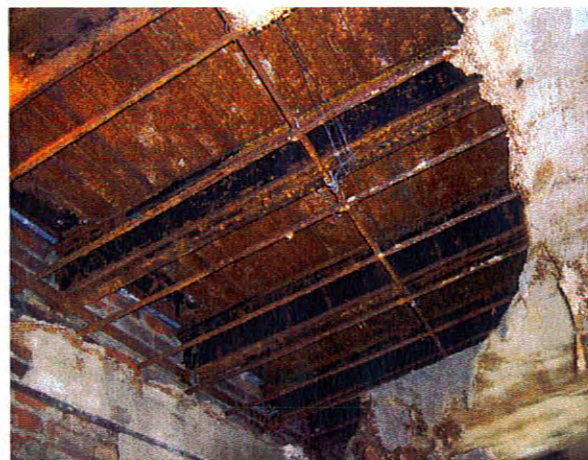
Second Floor Beams and Decking

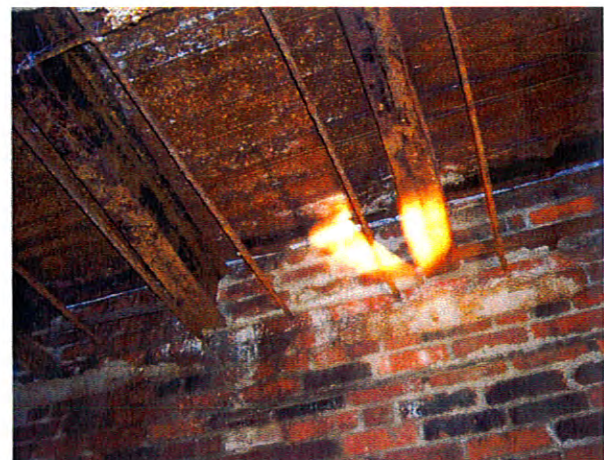
Second Floor Beams and Decking

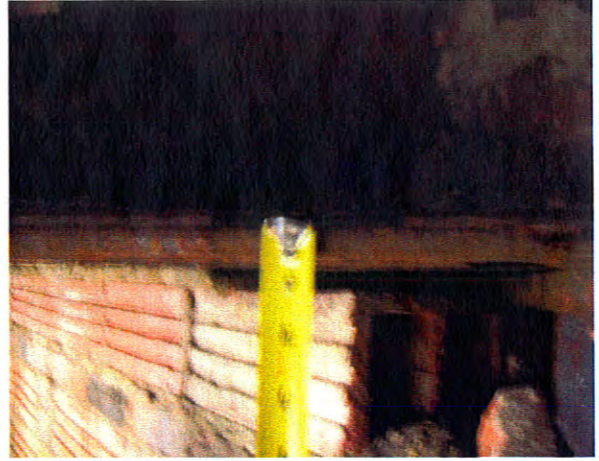
Lower Flange Thickness Measurements

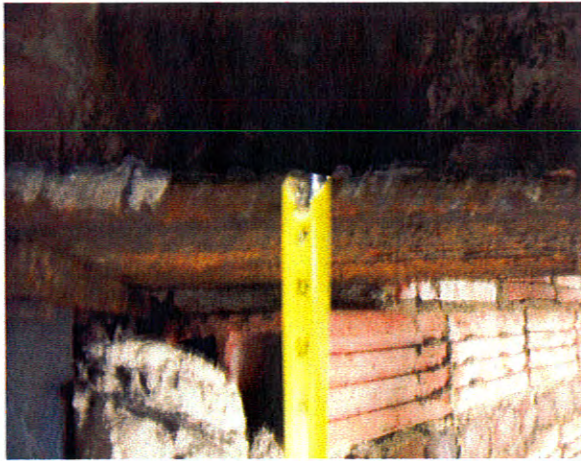
Truss Bearing Plate Thickness Measurements

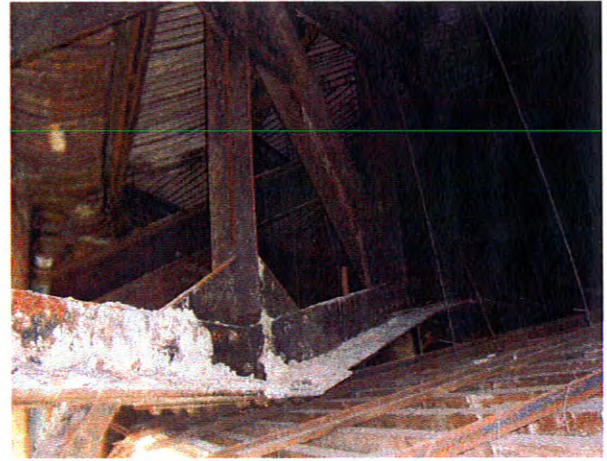
Below the cupola are band and plate connections for the intersecting domed trusses. We observed a good deal of moisture damage as a result of long term water leakage here.

Truss and Dome Area

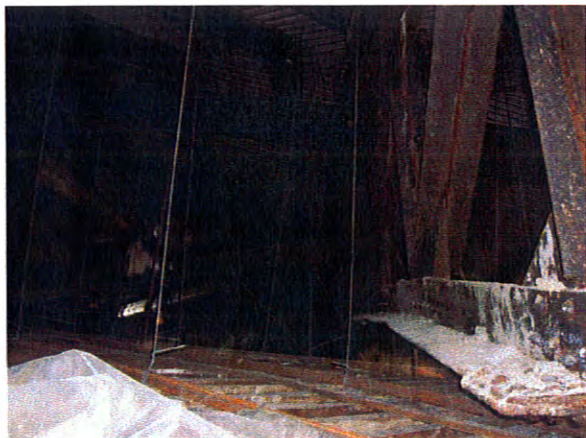
Truss and Dome Area

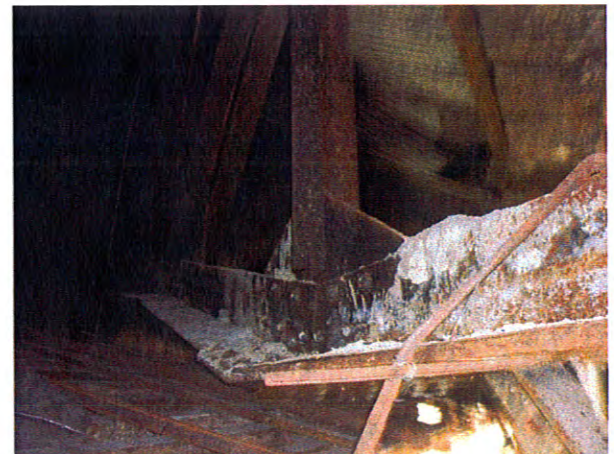
Truss and Dome Area

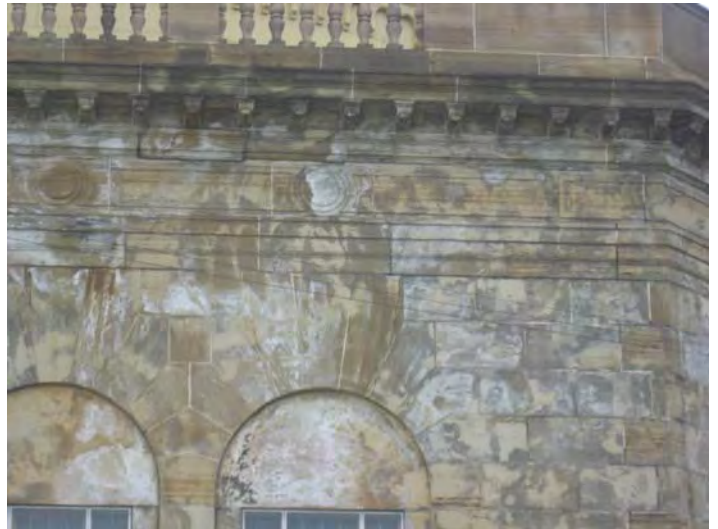
East elevation detail showing efflorescence

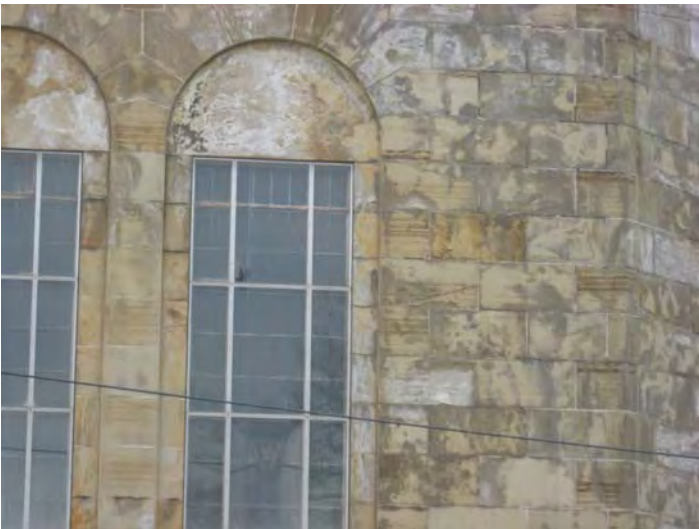
East elevation detail showing efflorescence

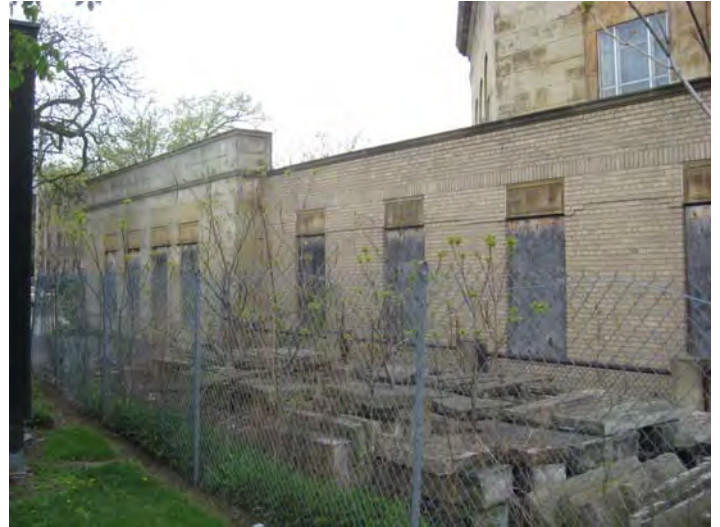
One-story wing, salvaged sandstone from demolished mech. room.

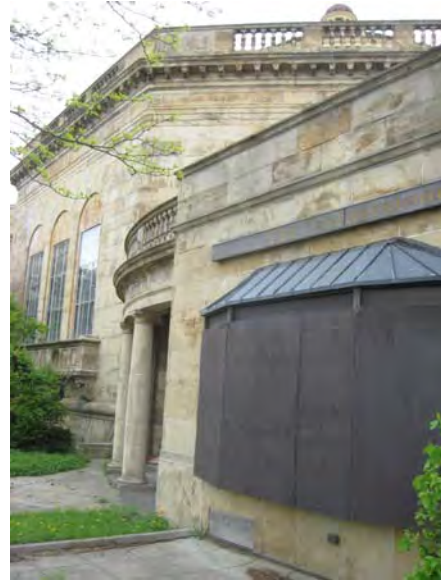
View from southwest

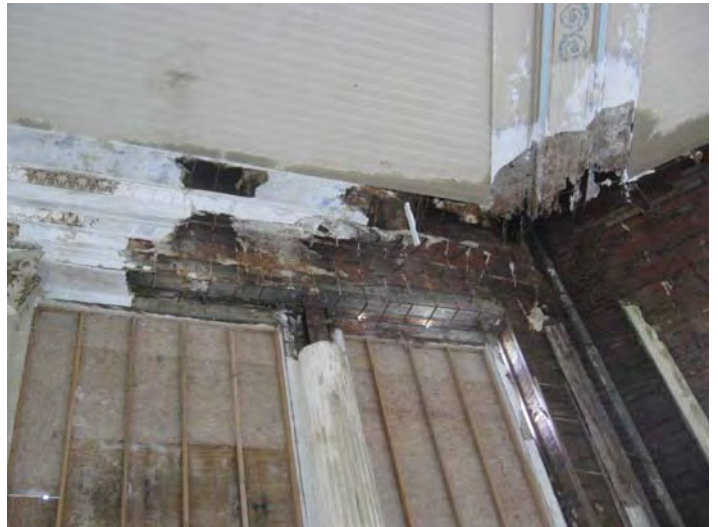
Typical condition at sanctuary wall / ceiling

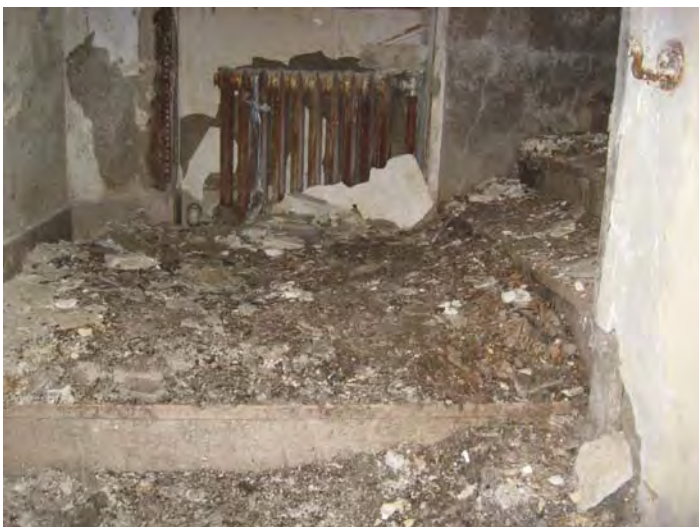
Northeast basement stairs. Stone covered with plaster debris.

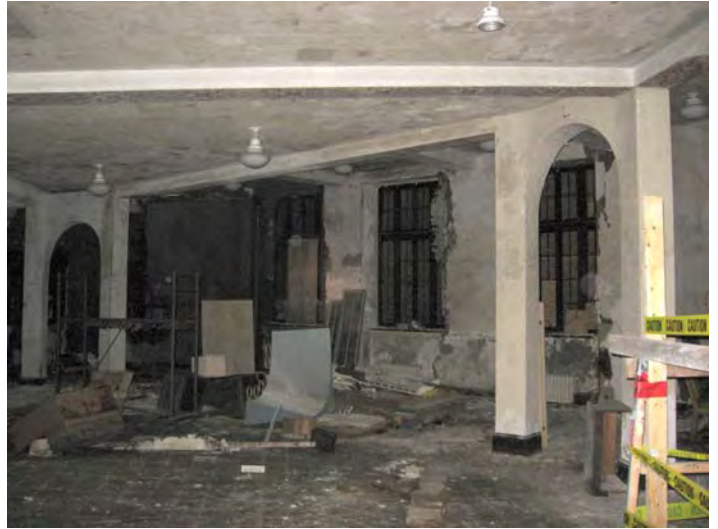
Basement social hall

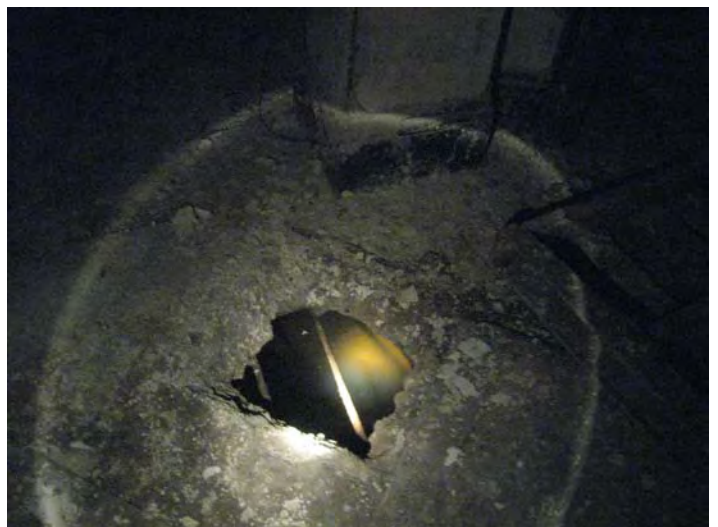
Flooded underslab ductwork in basement

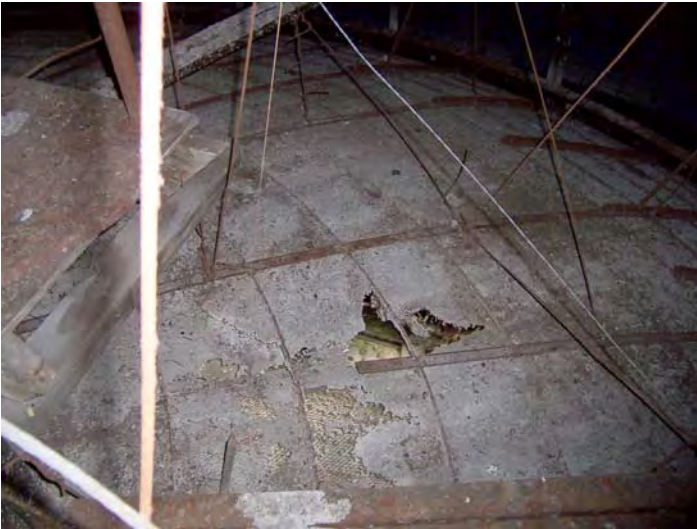
Hole in plaster dome

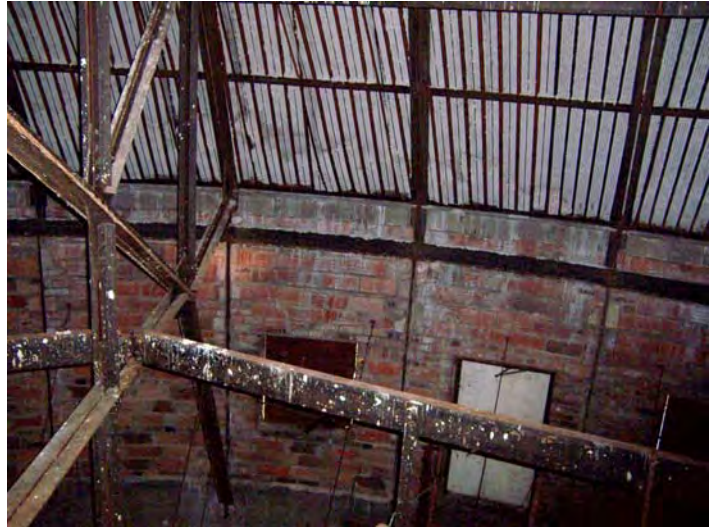
Roof truss under cupola. View to dome perimeter.

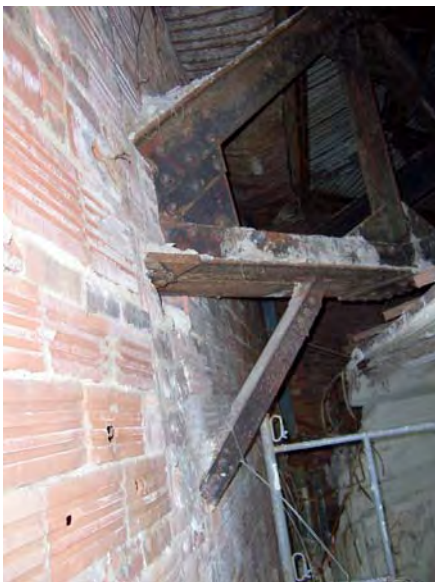
Primary truss bearing at west wall, northern truss.

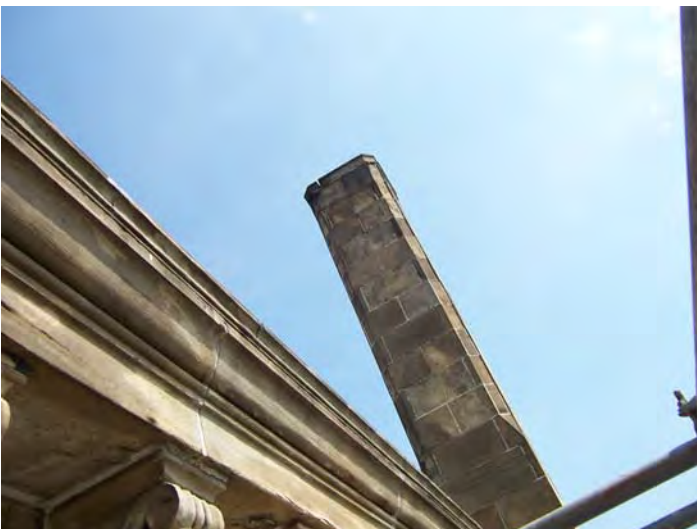
Chimney from west

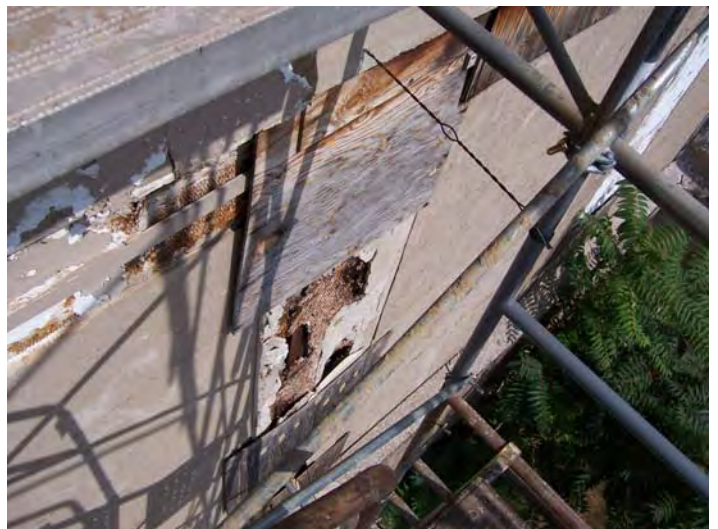
Temporary plywood wall infill, southeast wall
